Investigation of Romanian forests in Natura 2000 sites Authors Bruna Campos, EuroNatur Catalina Radulescu, Agent Green

Reference: Agent Green and EuroNatur (2023): Investigation of Romanian forests in Natura 2000 sites.

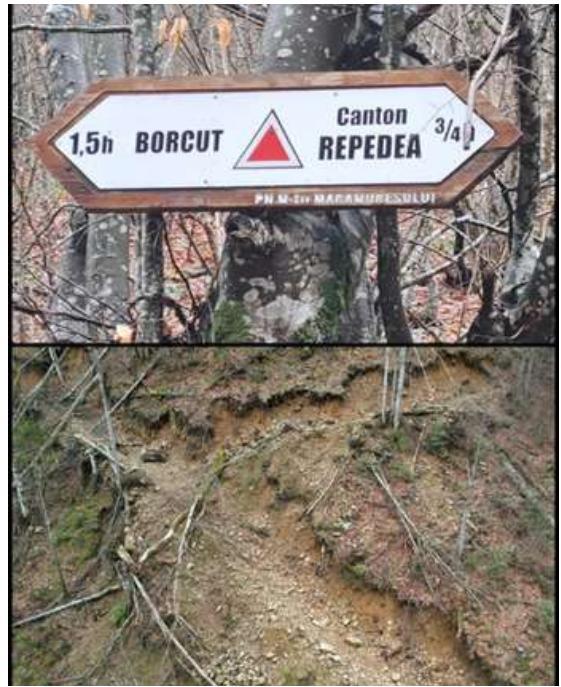
Figure 6: (top) photo of official hiking trail markings inside Maramures Natura 2000 site; (bottom) photo of recent logging roads and eroded soil. Both photos were taken in March 2023

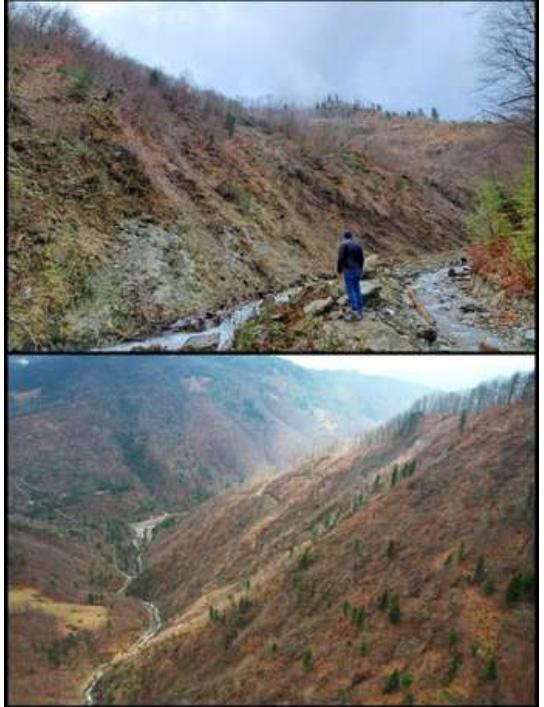
*Figure 8: (top) photo of recent logging; (bottom) aerial photo of logged area. Both photos were taken in March 2023.*

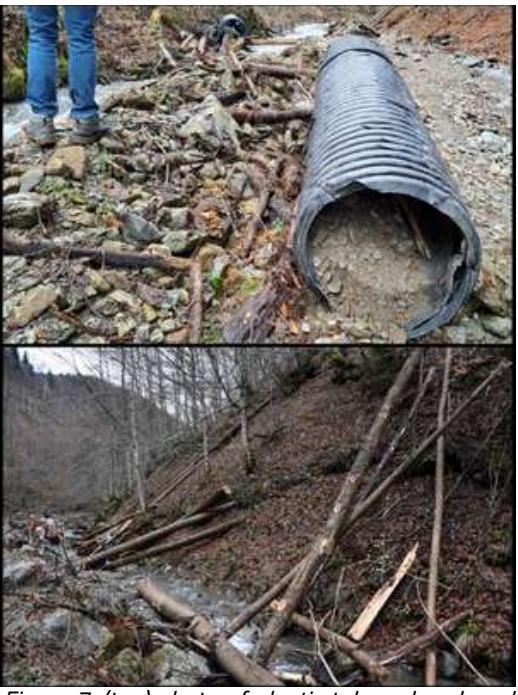
Figure 7: (top) photo of plastic tubes abandoned on the ground pollute the river and riverbed; (bottom) recently cut logs that have been abandoned on the local river. Both photos were taken in March 2023.

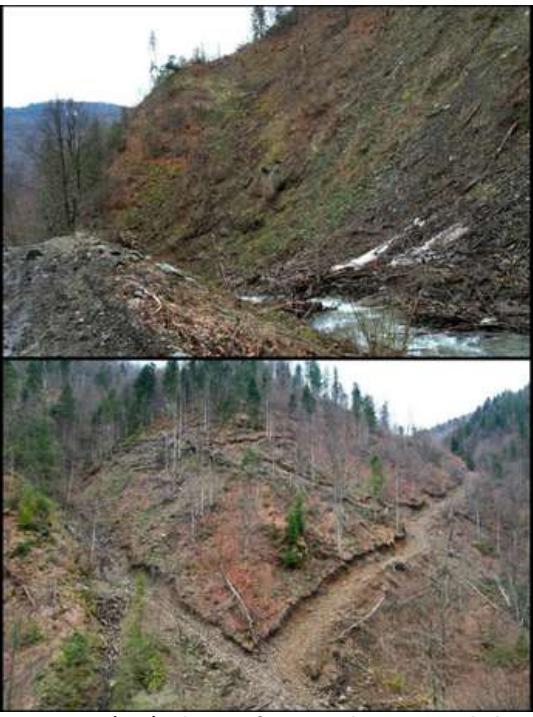
Figure 9: (top) photo of recent logging with logs being dragged and abandoned in the local river; (bottom) aerial photo of recent logging roads. Both photos were taken in March 2023.

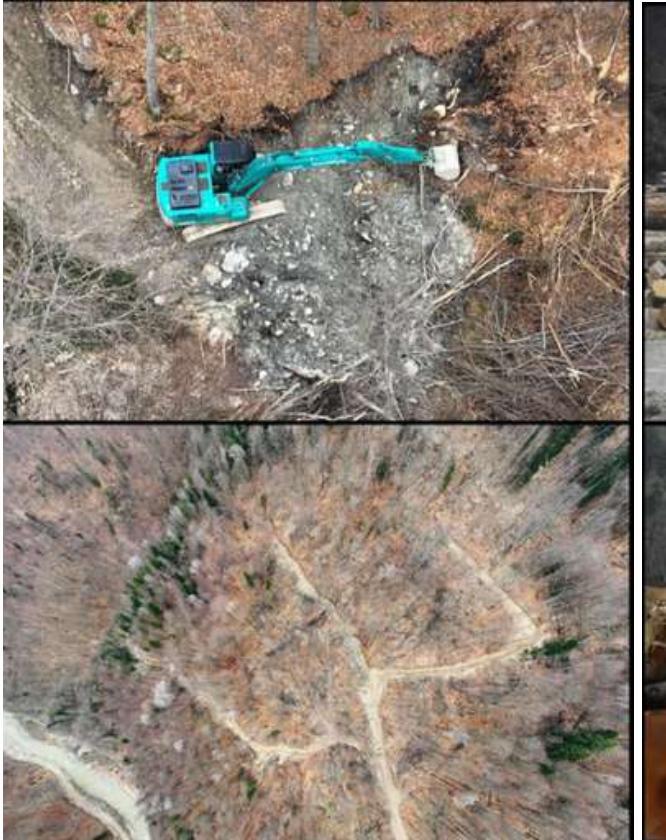
Deep logging roads are present everywhere throughout the area, with signs of heavy erosion. Logging is also taking place on steep slopes, of over 30% inclination, and heavy machinery such as excavators and diggers are being used to build new logging roads on steep slopes that are prone to erosion.

Figure 10: (top) close up aerial photo of heavy machinery excavating new logging roads; (bottom) aerial photo of new logging site. Both photos are taken in March 2023.

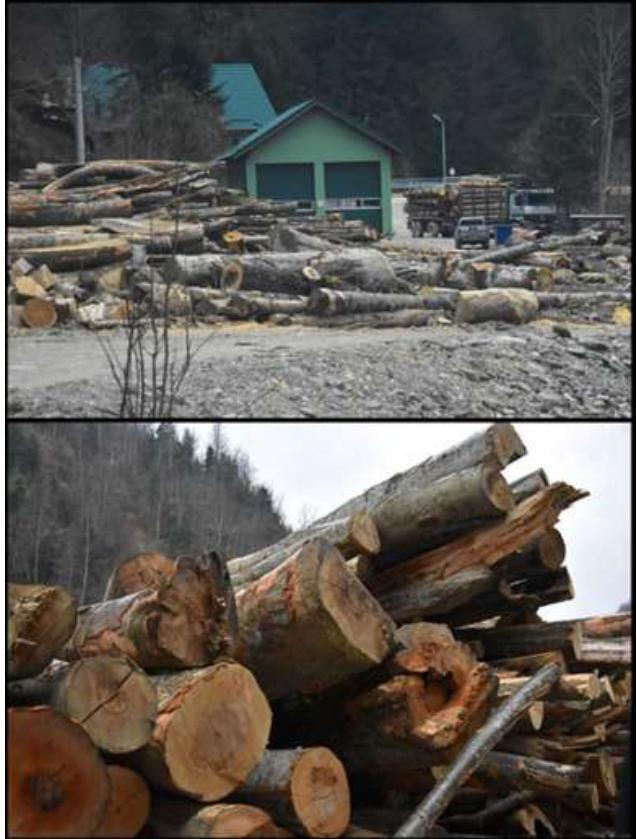
Figure 11: (top) photo of a local log yard and trucks in the vicinity of the logging site. (bottom) close-up photo of large logs from old forests. Both photos were taken in March 2023.

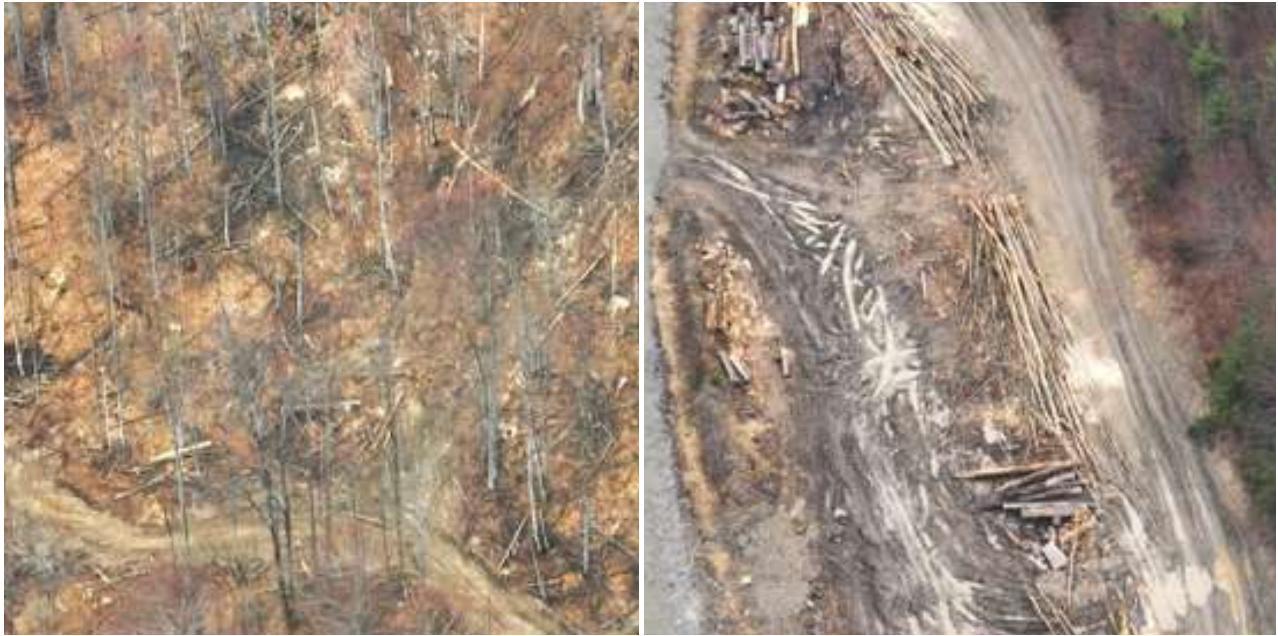
Logging permits in this area were given for accidental logging, but from the drone footage little evidence was found of windfells or dead trees to justify these types of interventions. Furthermore, the drone footage also showed several sites that were impacted by habitat fragmentation following recent successive interventions that removed over 2500 m<sup>3</sup> in volume, but very little evidence to support the need to remove such large volumes of wood.

Figure 12: (left) close up aerial photo of recent logging showing that the majority of trees have been cut and not damaged by wind, as claimed by administrators; (right) aerial photo of local wood depot by the side of the river with signs of wood being dragged through water. Both photos were taken in March 2023.

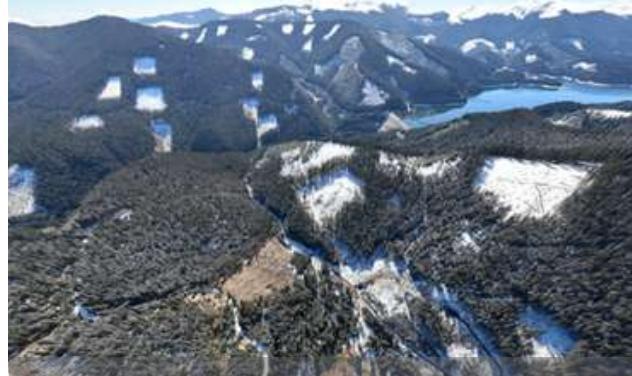
Figure 17: aerial photo of the area showing a heavily fragmented landscape, taken in March 2023

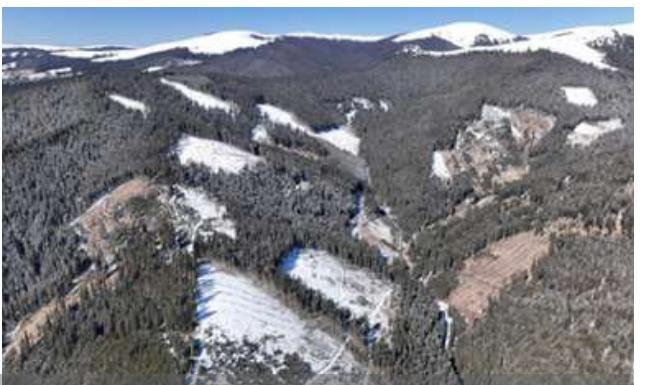
Figure 18: aerial photo of the area showing several clear-cuts impacting this area, taken in March 2023

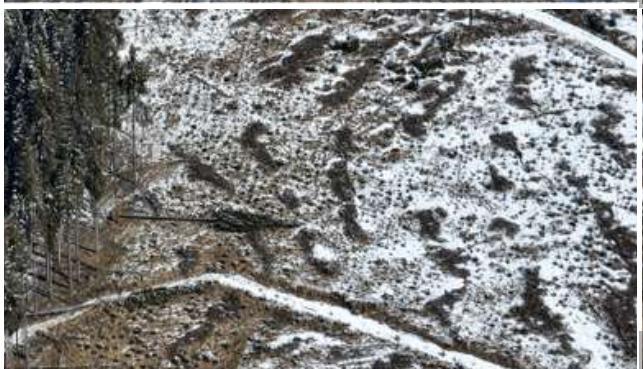
Figure 19: aerial close-up photo of a recent clearcut, taken in March 2023

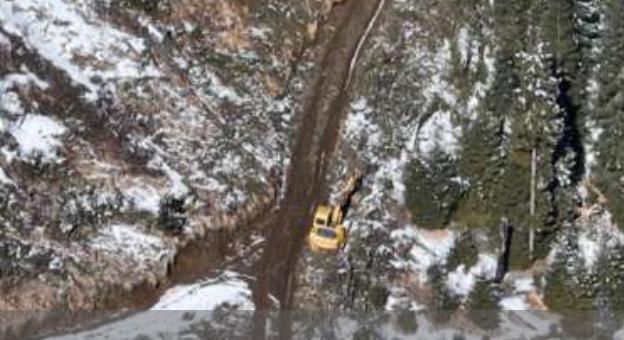
Figure 20: photo of heavy machinery - excavator digging a new logging road; (bottom) photo of a forest wood deposit. Both photos are taken in March 2023

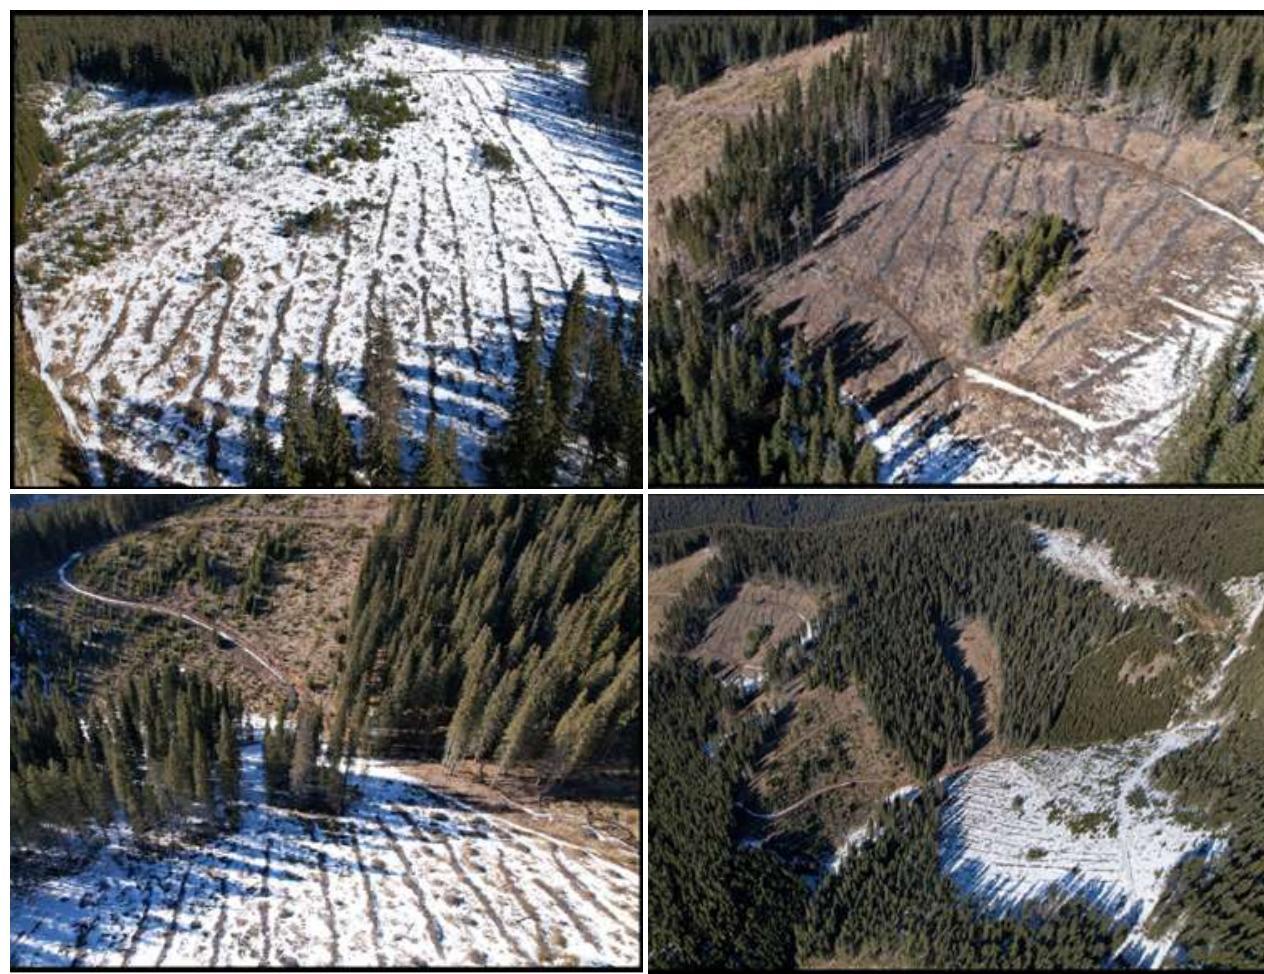
*Figure 27: close-up aerial photos of recent logging. Both photos were taken in March 2023*

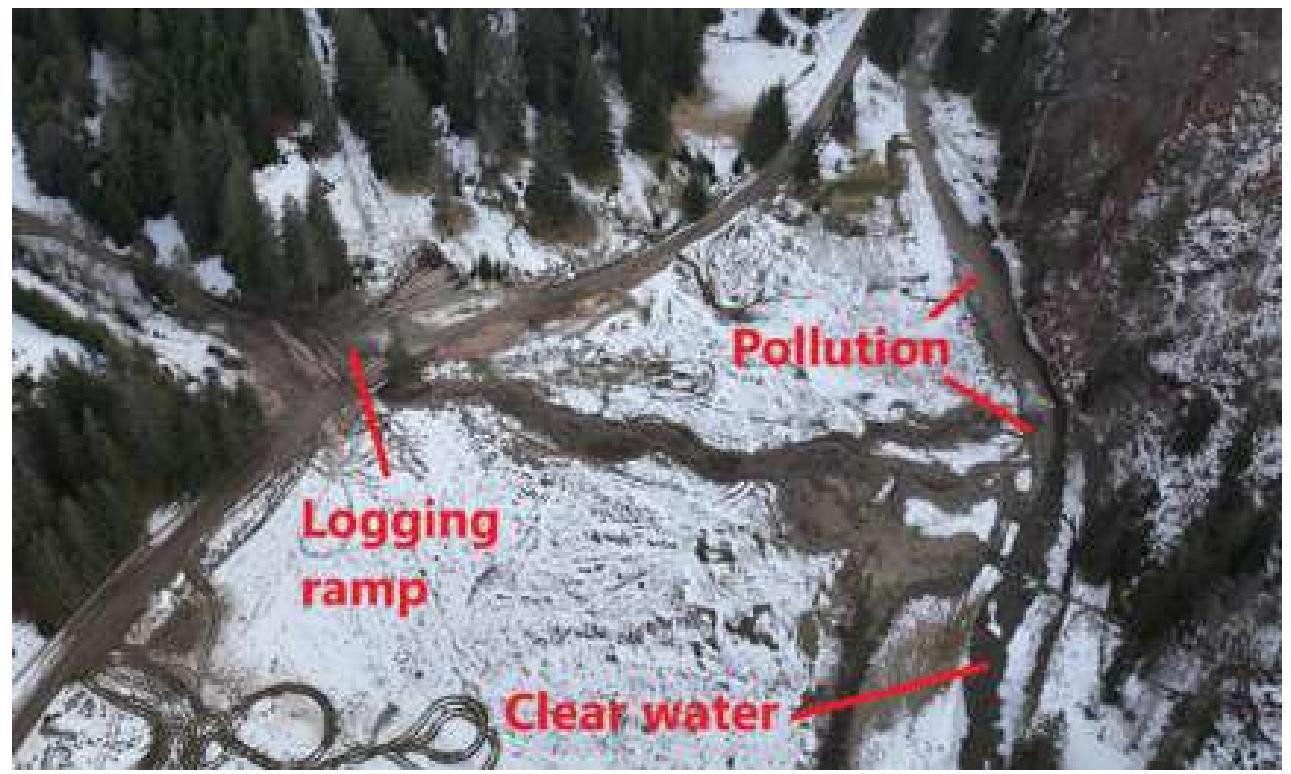
Unfortunately, logging is allowed on the steep slopes surrounding the Valsan River. The most recent logging resulted in the degradation of the Valsan River due to tractors pulling logs through the nearby stream despite assumable negative impacts on *Romanchthys valsanicola*.

Figure 34: aerial photo of logging ramp showing muddy, polluted runoff spilling into Valsan River, taken in February 2023.

Agent Green submitted a complaint to the authorities on the 21st of February 2023. Both the Forest Guard and the Environmental Guard visited the site. They fined both the administrators and the logging company but allowed them to continue logging, provided that another logging road is used to bring down logs that does not degrade the river.

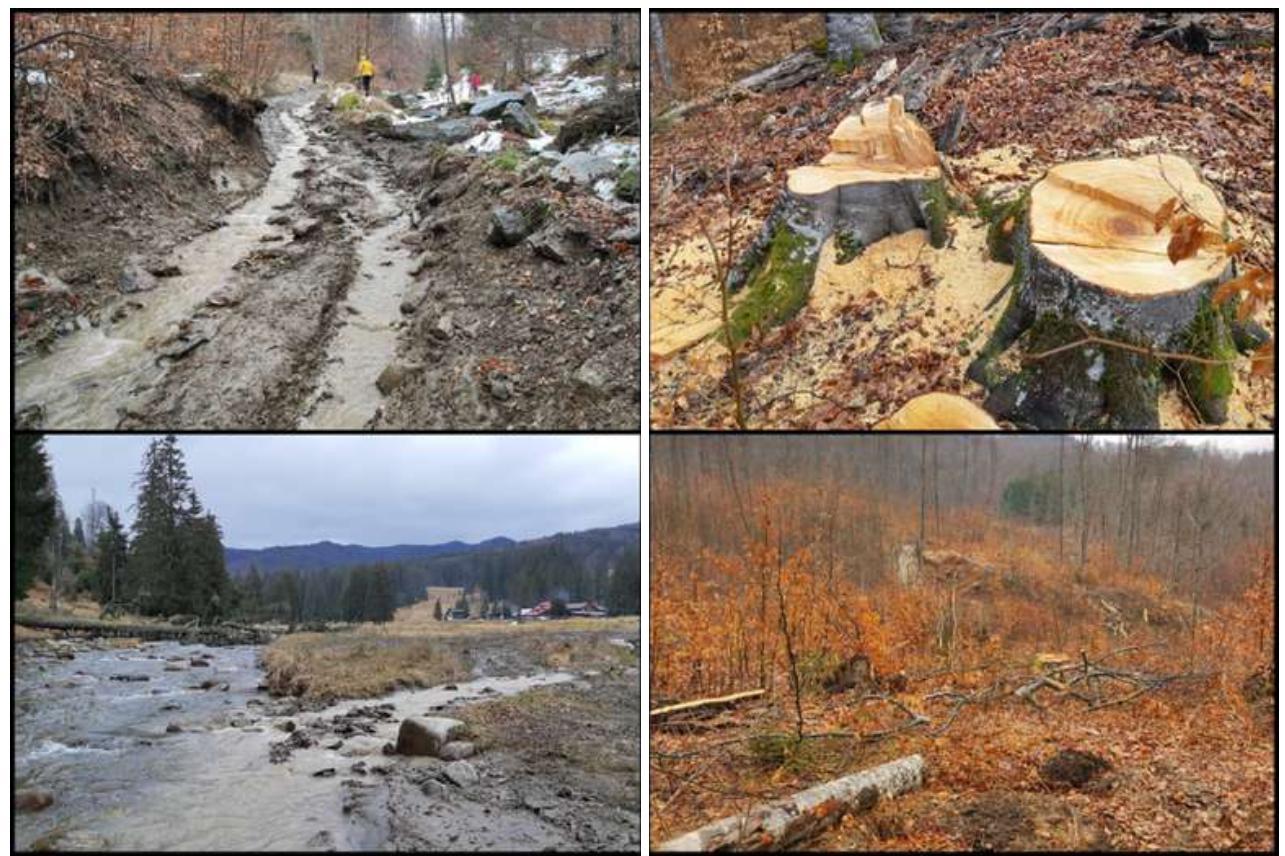
Figure 35: (top) photo of muddy logging road; (bottom) photo of muddy waters entering Valsan River. Both photos were taken in February 2023

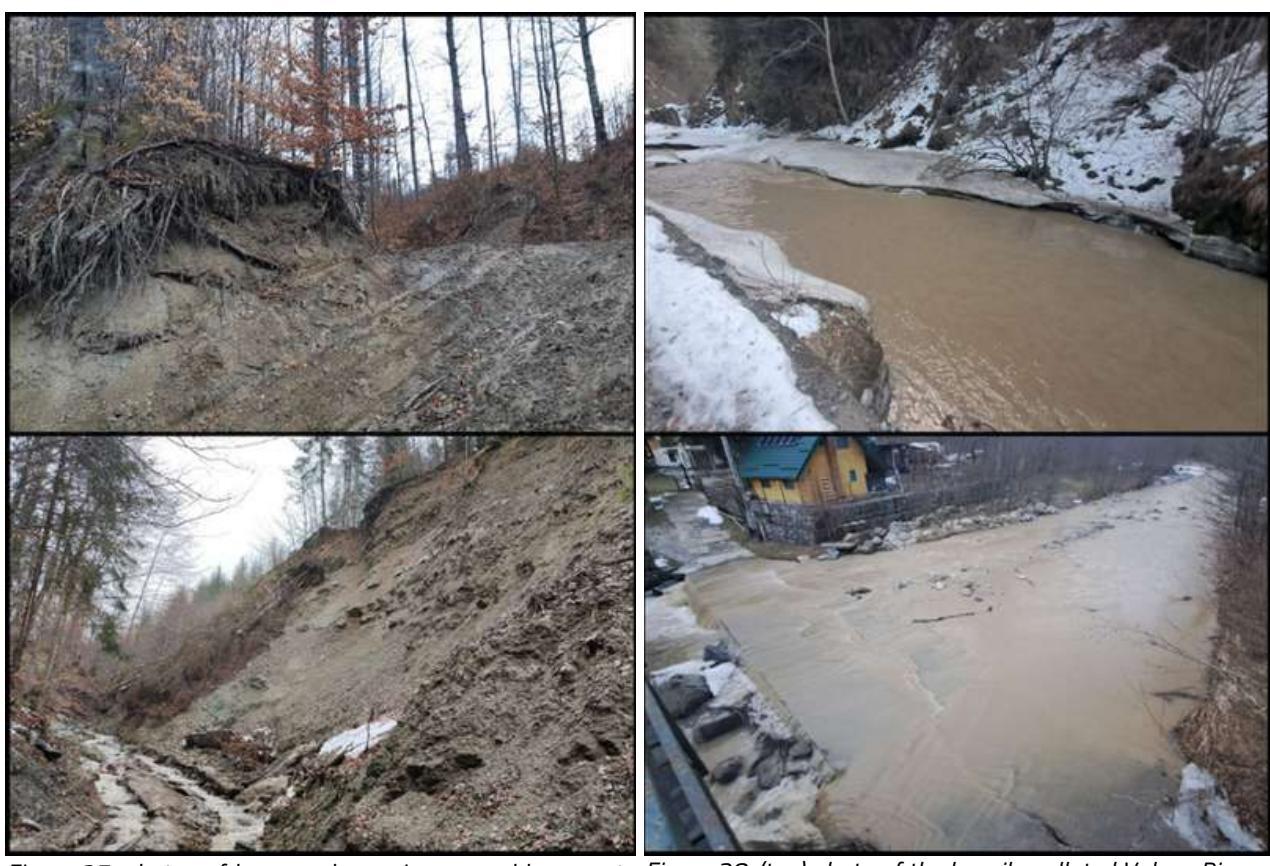
*Figure 37: photos of large-scale erosion caused by recent logging works. Both photos were taken in February 2023.*

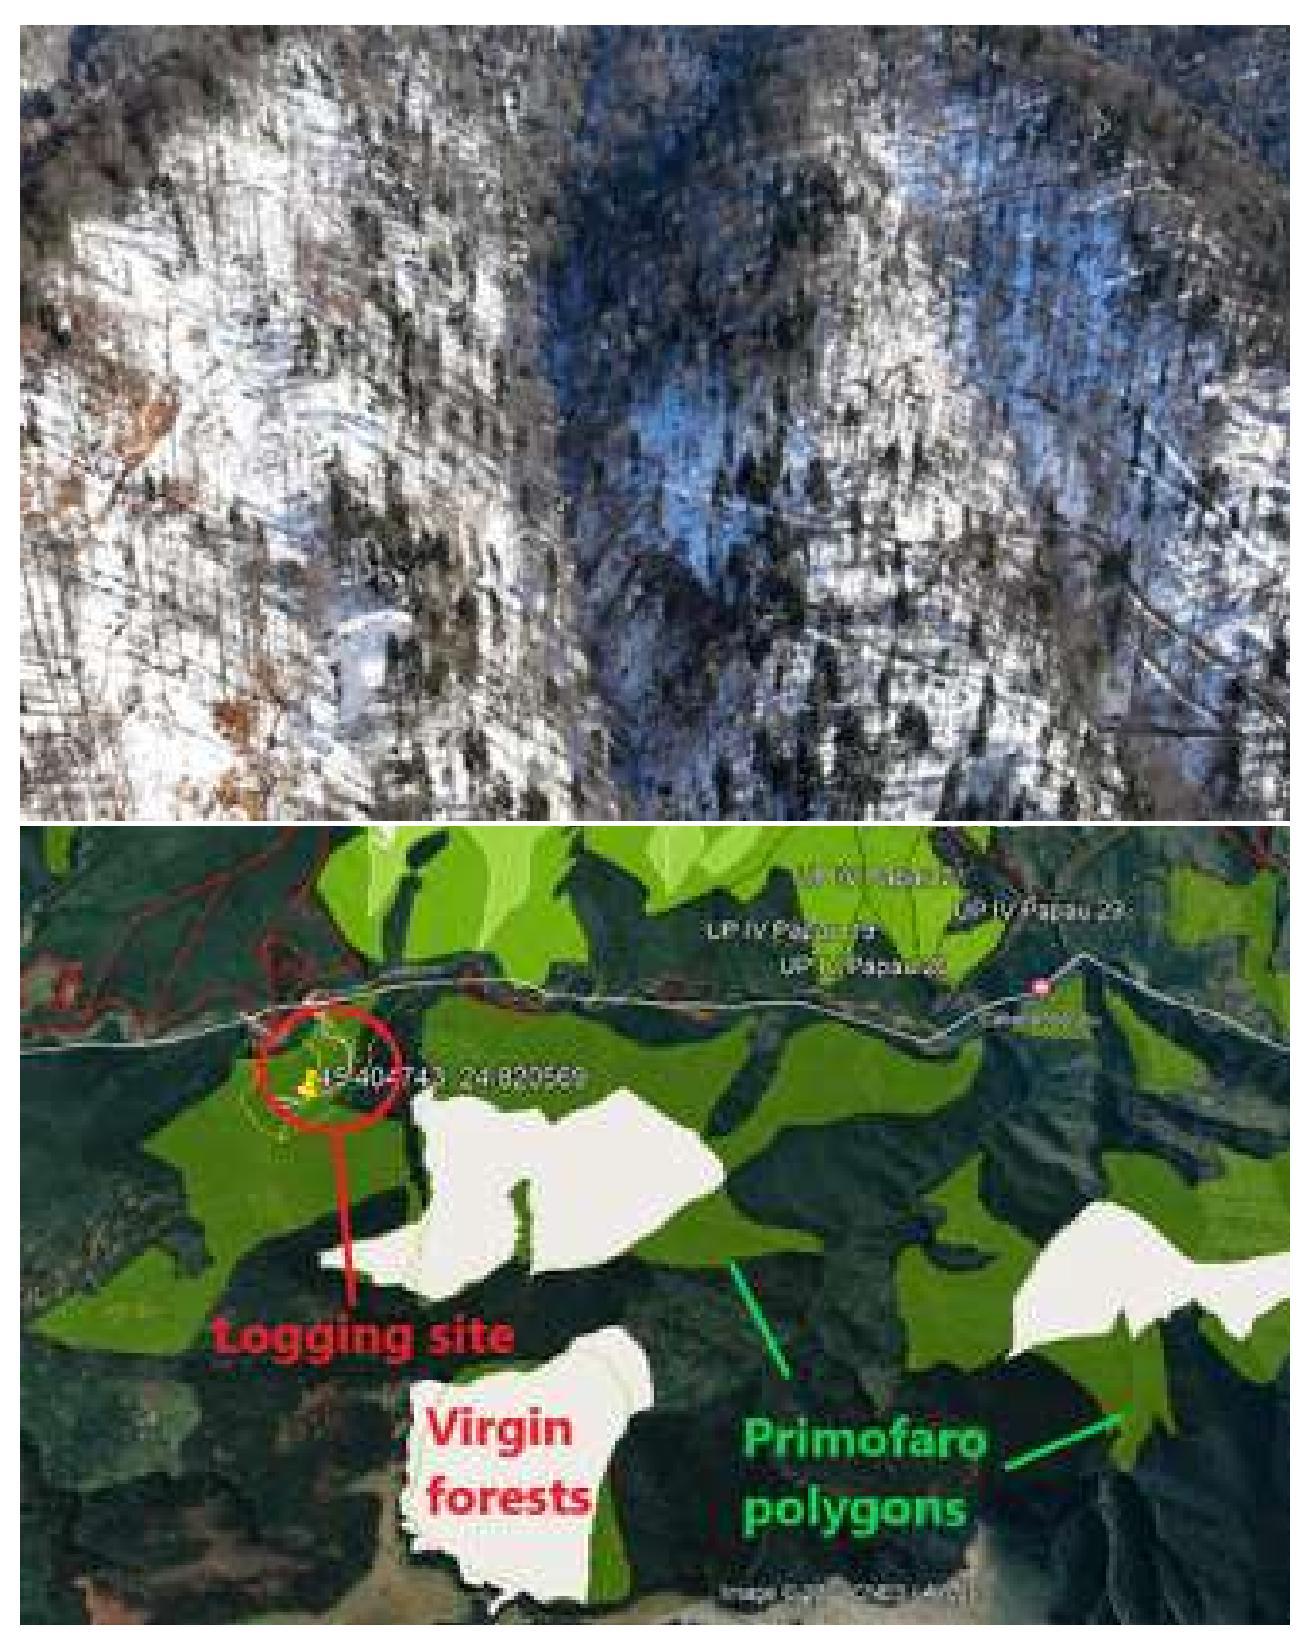
Figure 40: (top) aerial photo showing a large network of new logging roads, taken on 10.02.2023 and (bottom) Google Earth photo of the location of recent logging relative to the Virgin forests in the Romanian National Catalog (in white) and PRIMOFARO study (in green).

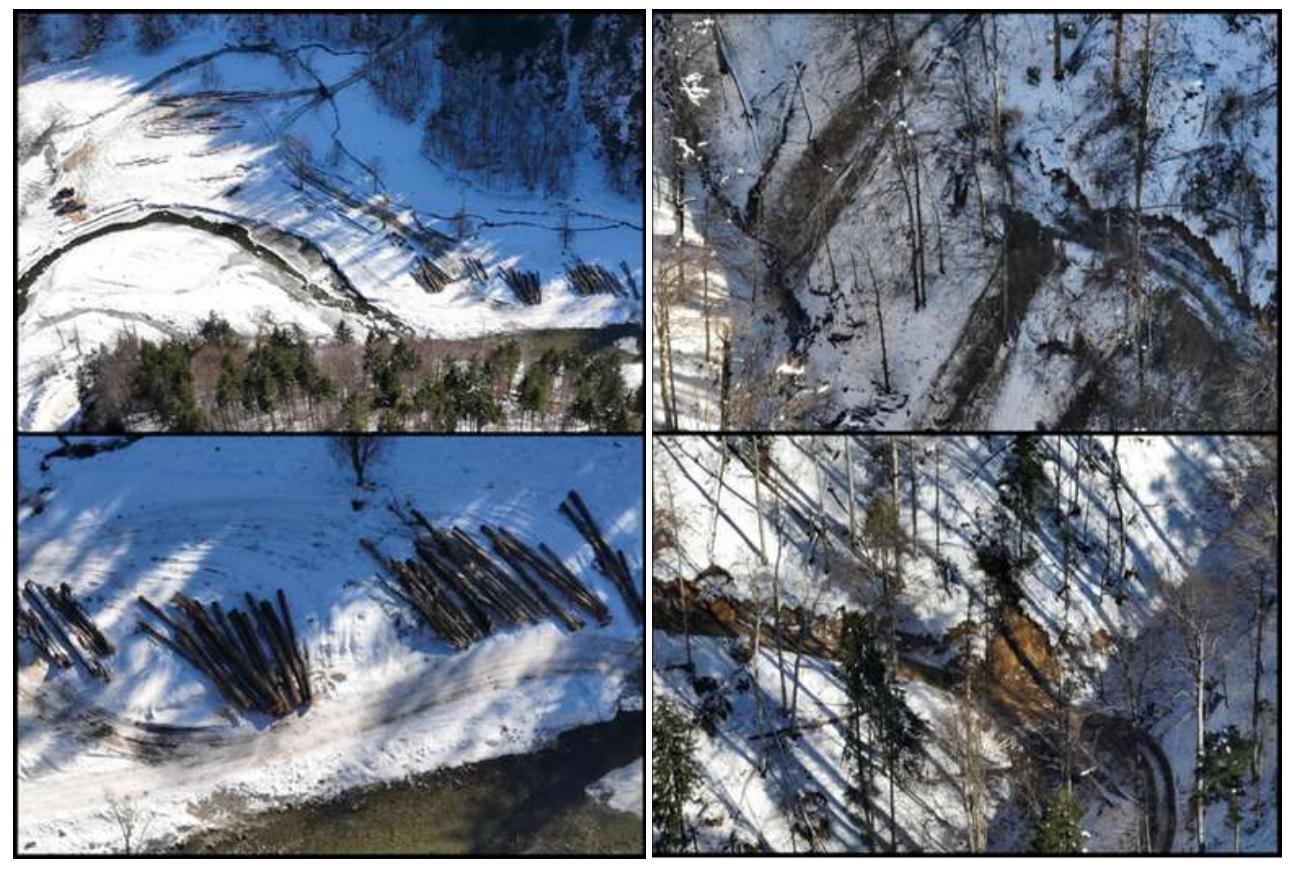
Figure 41: (top) photo of the primary ramp for storing logs, Figure 42: (top) aerial photo of recent logging. (bottom) near logging site; (bottom) aerial close up of large logs, typical of old forests. Both photos were taken in February Both photos were taken in February 2023. 2023.

aerial close-up of a large logging road, prone to erosion.

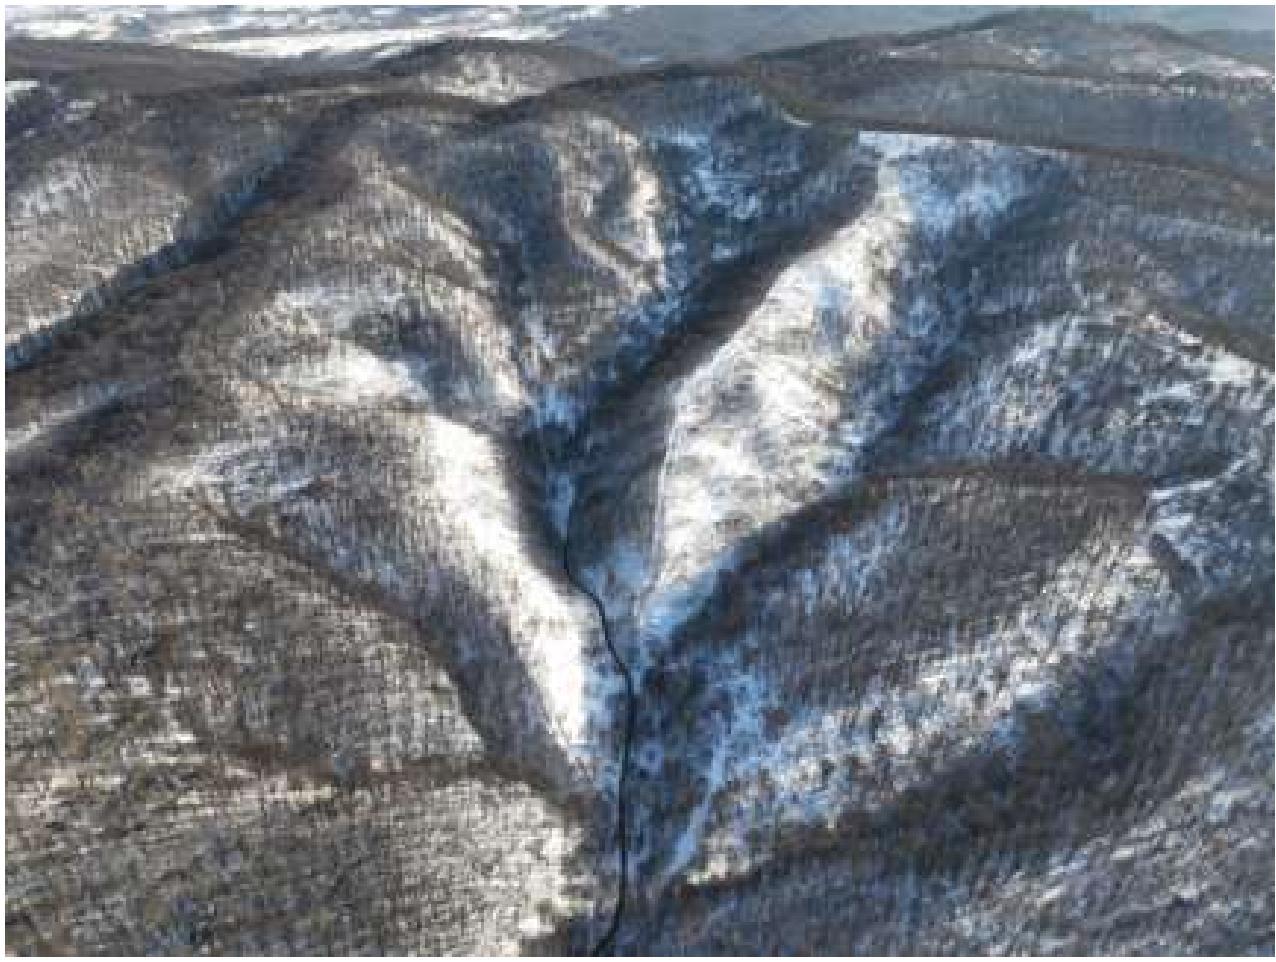
Figure 44: aerial photo of the area impacted by progressive logging, taken in February 2023.

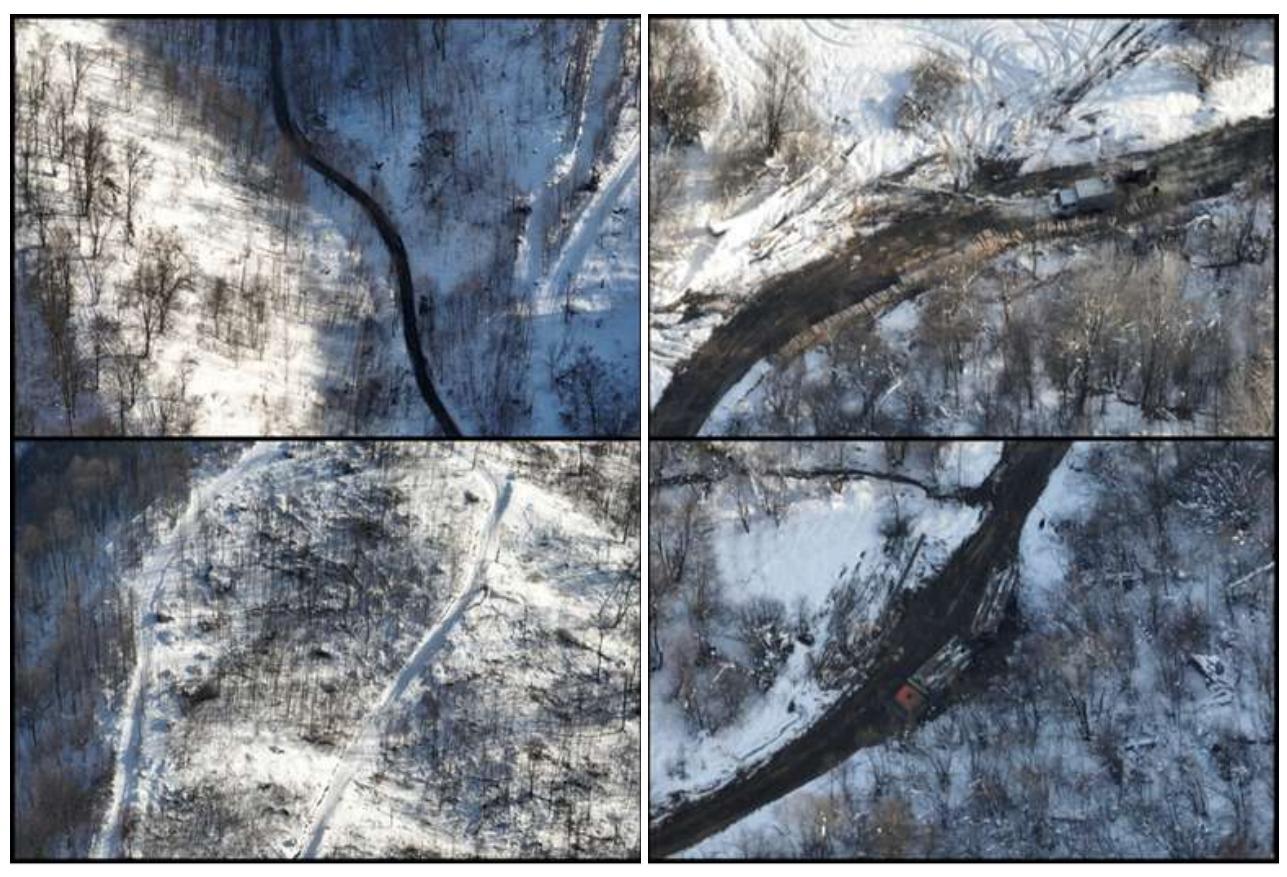
Figure 45: photos illustrating several eroded logging roads, some still in use. Both photos were taken in February 2023.

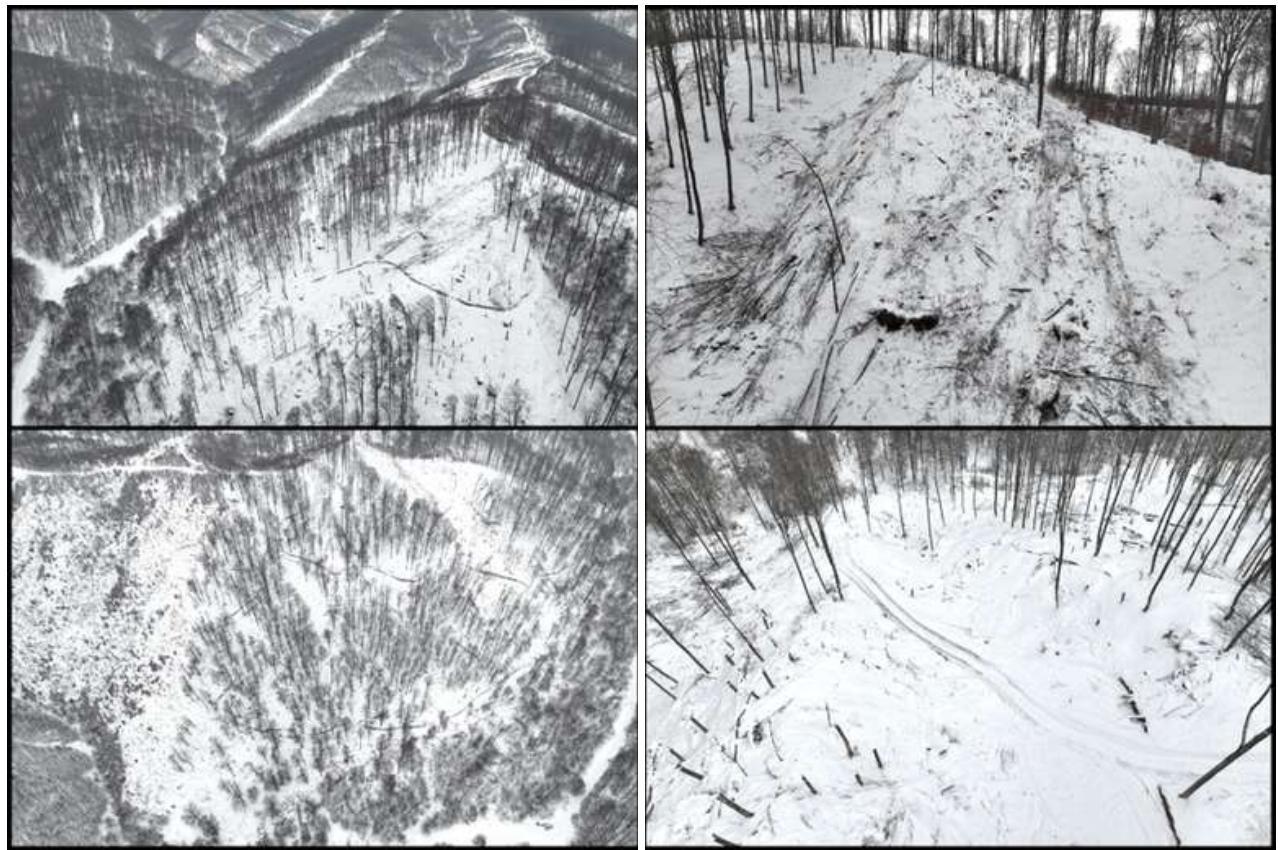
Figure 48: aerial photos of areas affected by recent Figure 49: aerial photos of areas impacted by recent progressive and accidental logging, taken in February logging, taken in February 2023. 2023.

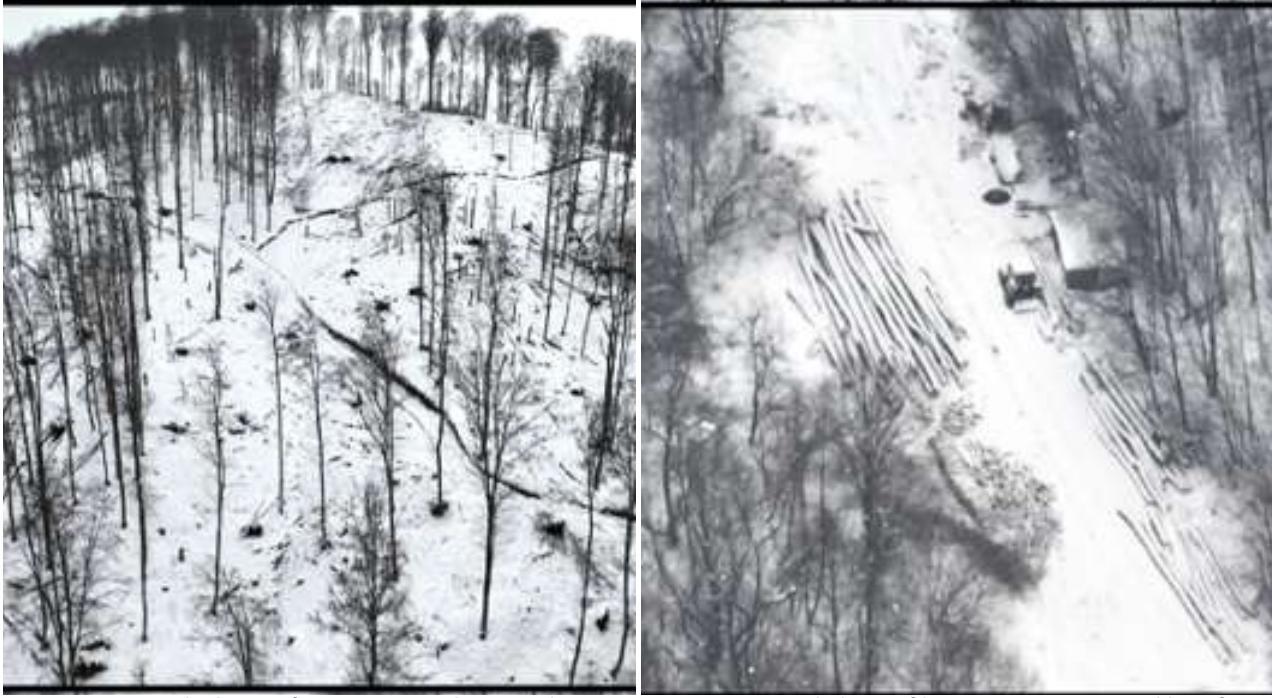
Figure 50: aerial photo of area impact by new logging roads prone to future erosion, taken in February 2023.

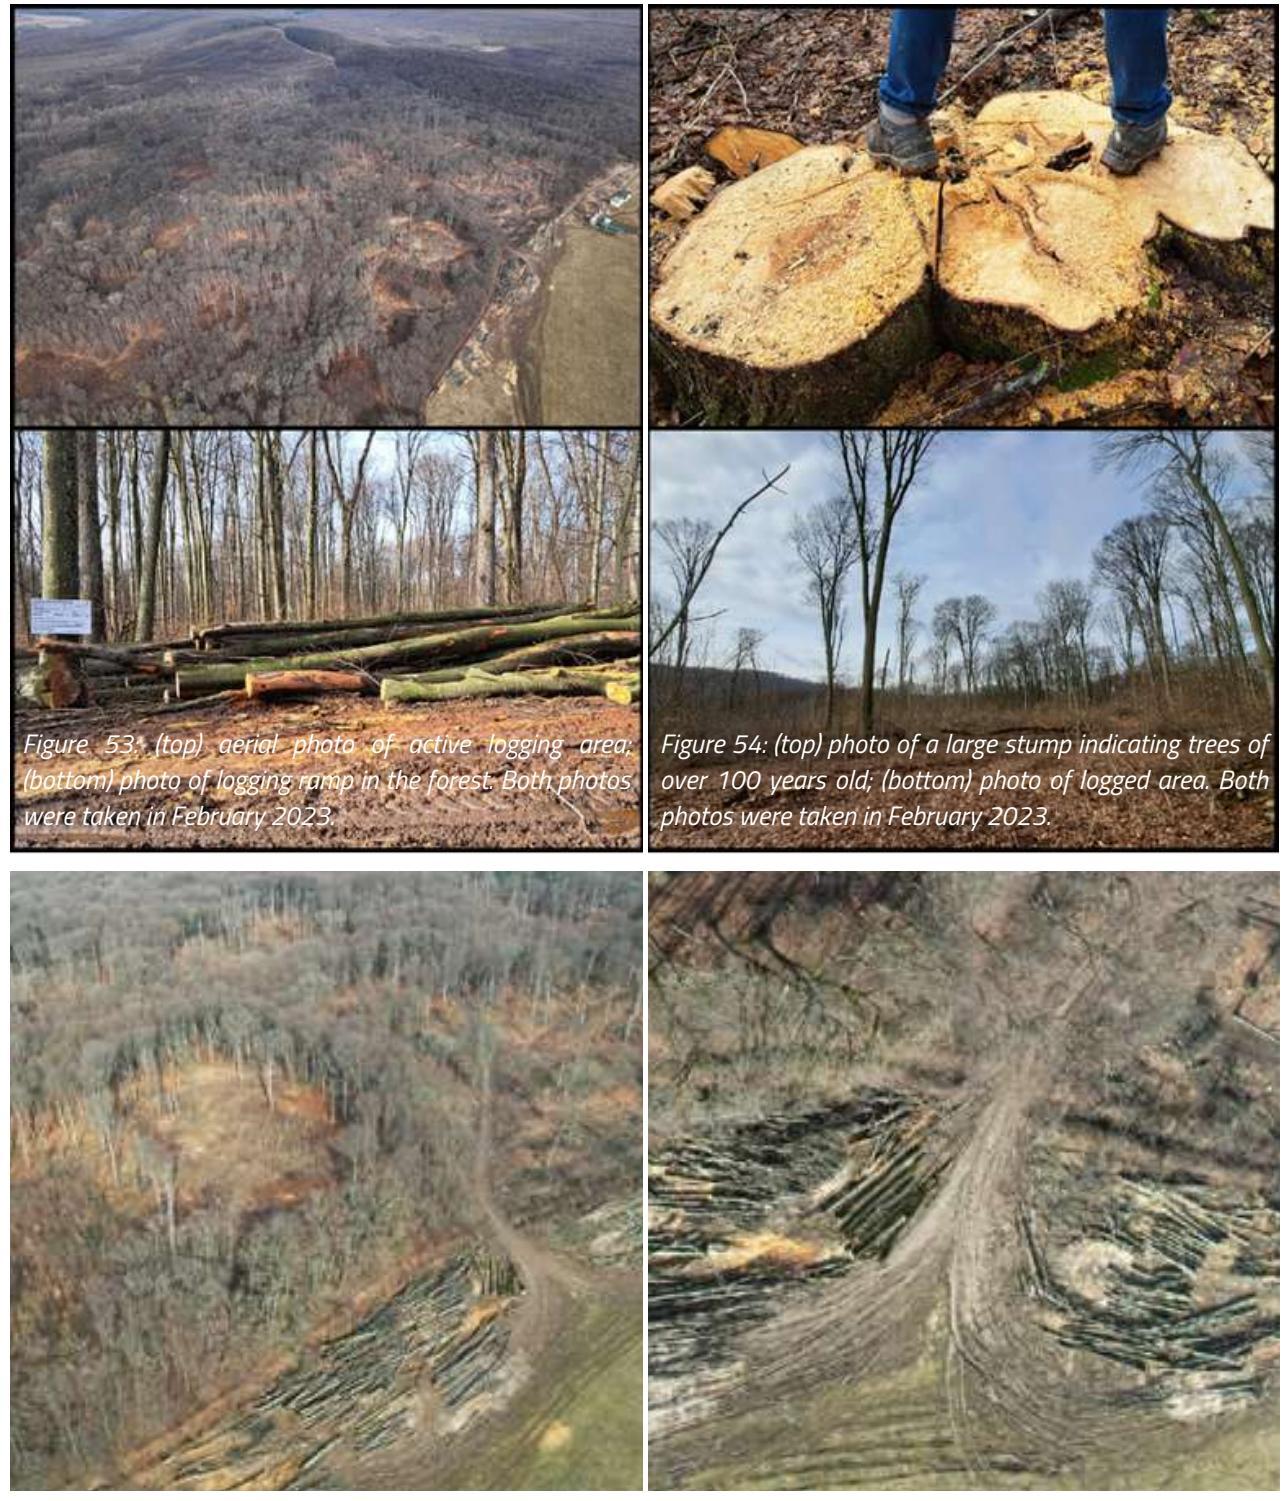
*Figure 55: (left) aerial photo of active logging area; (right) aerial close-up photo of logs from recent logging. Both photos were taken in February 2023.*

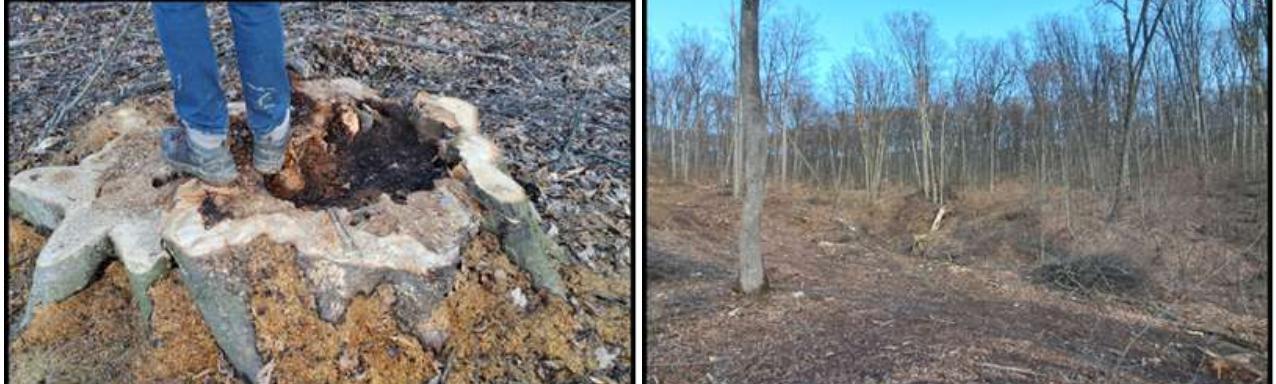
Figure 57: (left) photo of a large stump from a logged tree that is estimated to be over 200 years old; (right) photo showing the start of progressive logging in a previously intact forest. Both photos were taken in February 2023.

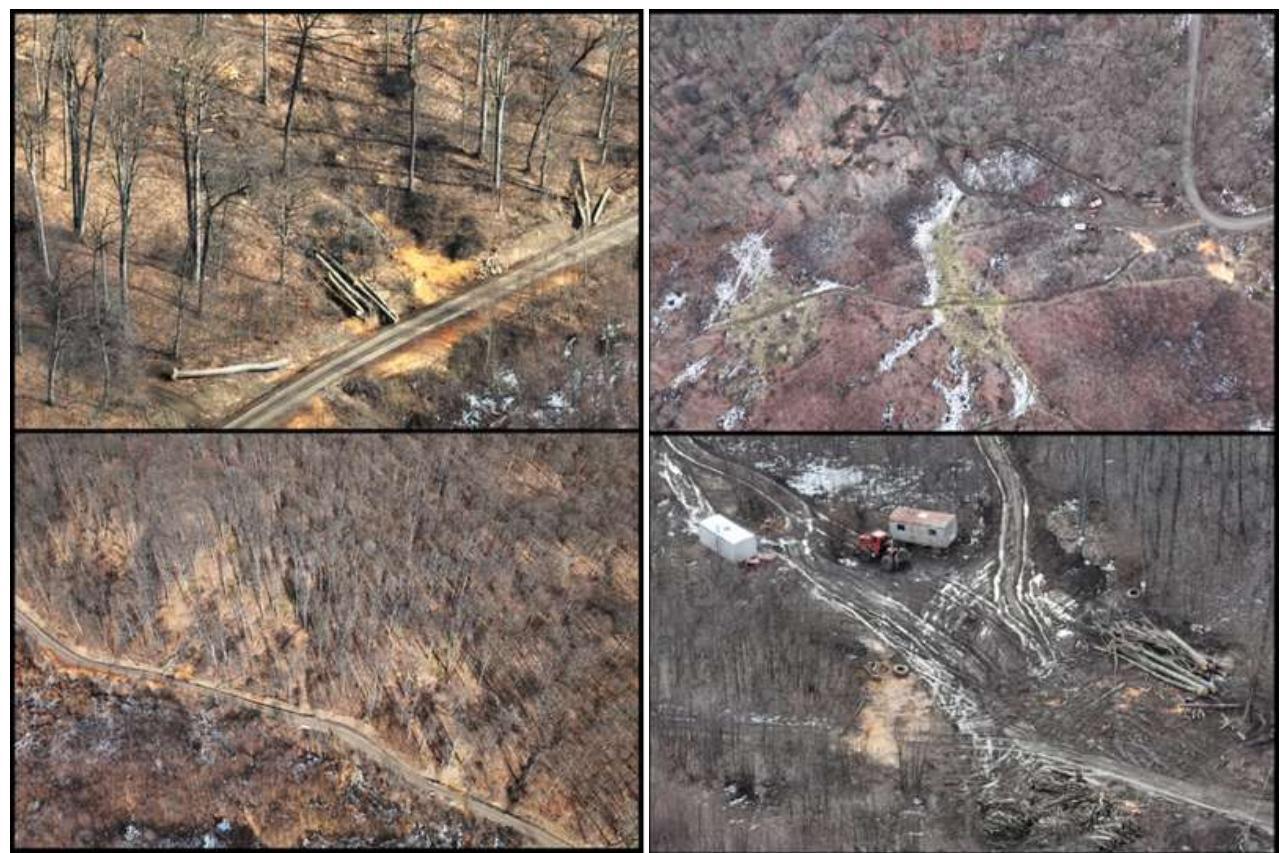
Figure 58: (top) aerial photo of active logging area with Figure 59: (top) aerial photo of the second active site in the recently cut logs; (bottom) aerial photo of the logging site. area; (bottom) close-up aerial photo of the loggers' Both photos were taken in February 2023.

campsite. Both photos were taken in February 2023.

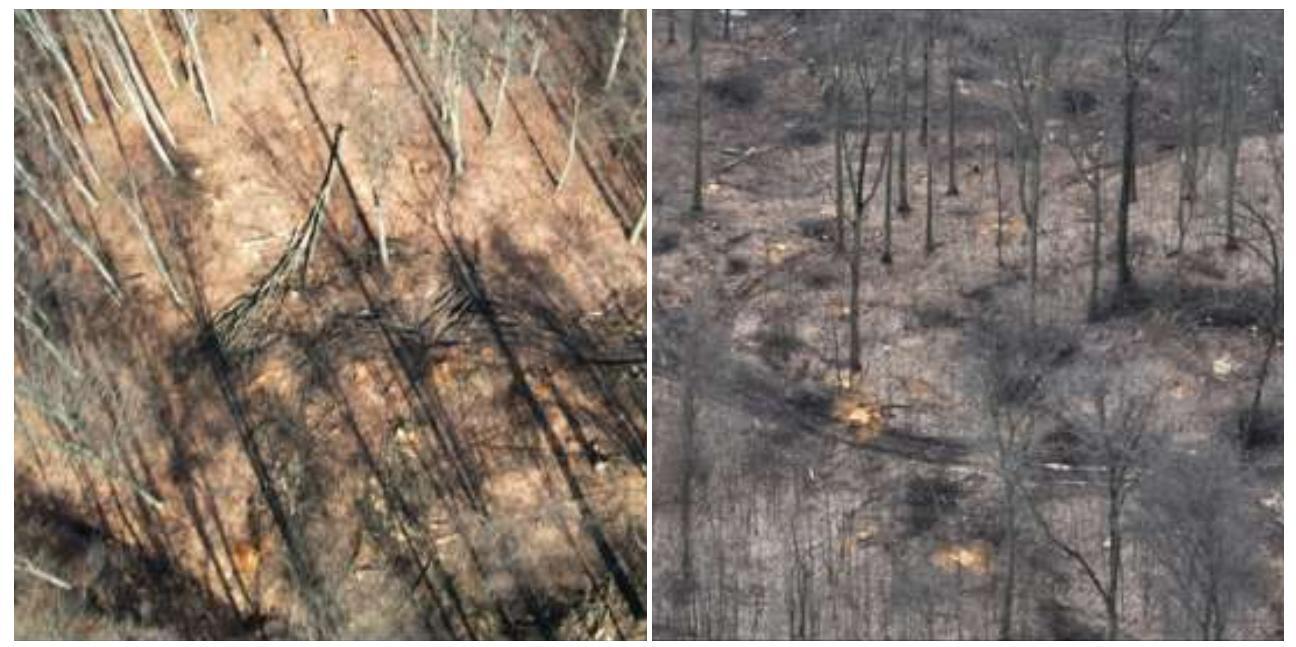
Figure 60: aerial photos of active logging sites. Both photos were taken in February 2023.
