Investigation of Romanian forests in Natura 2000 sites Authors Bruna Campos, EuroNatur Catalina Radulescu, Agent Green

Reference: Agent Green and EuroNatur (2023): Investigation of Romanian forests in Natura 2000 sites.

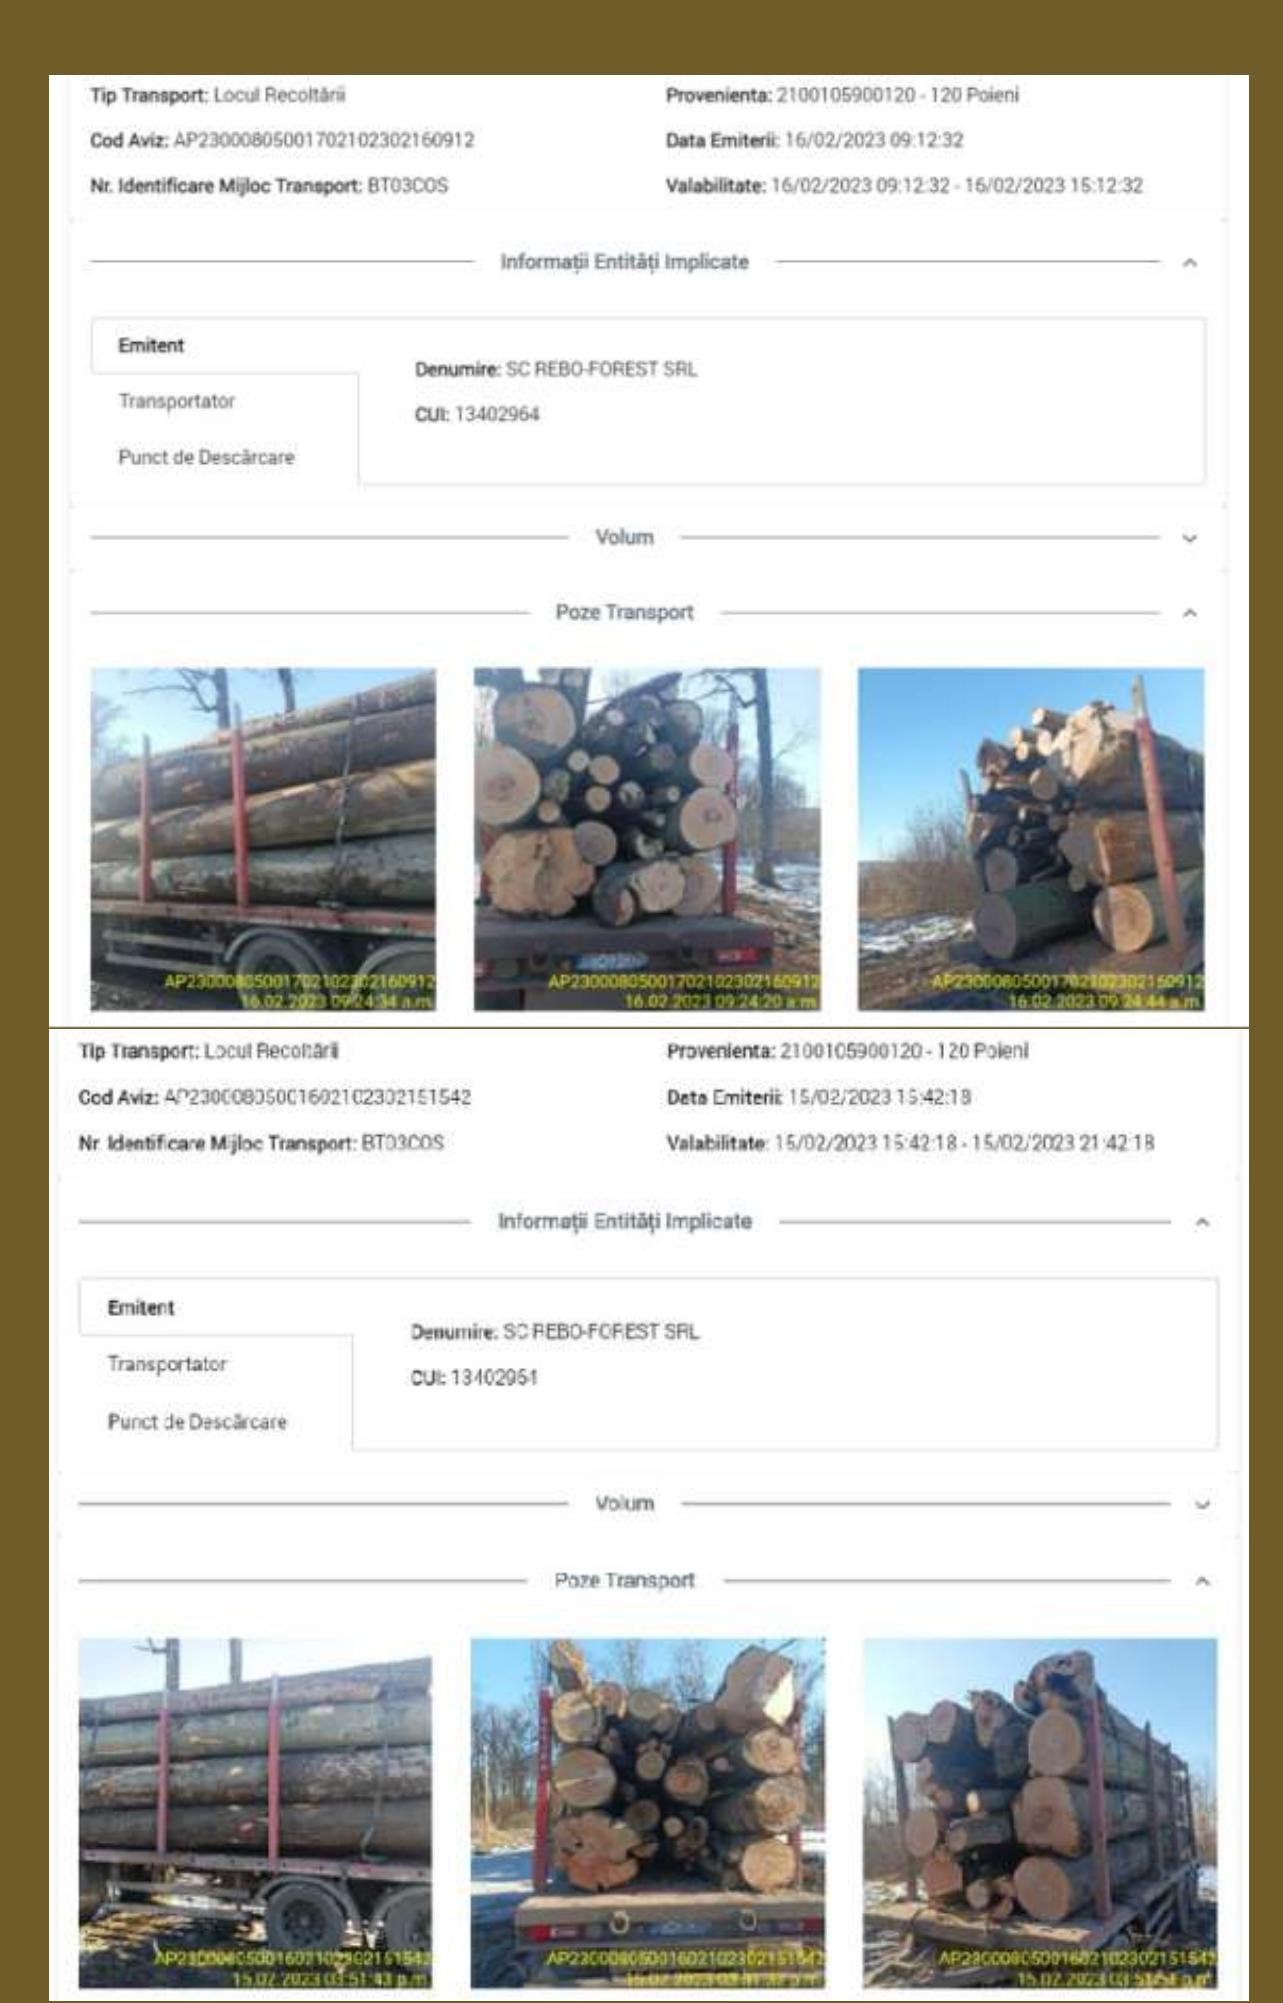
Figure 61: declaration of vehicles transporting wood for APV #2100105900120 showing photos of ancient trees being removed from logging site.

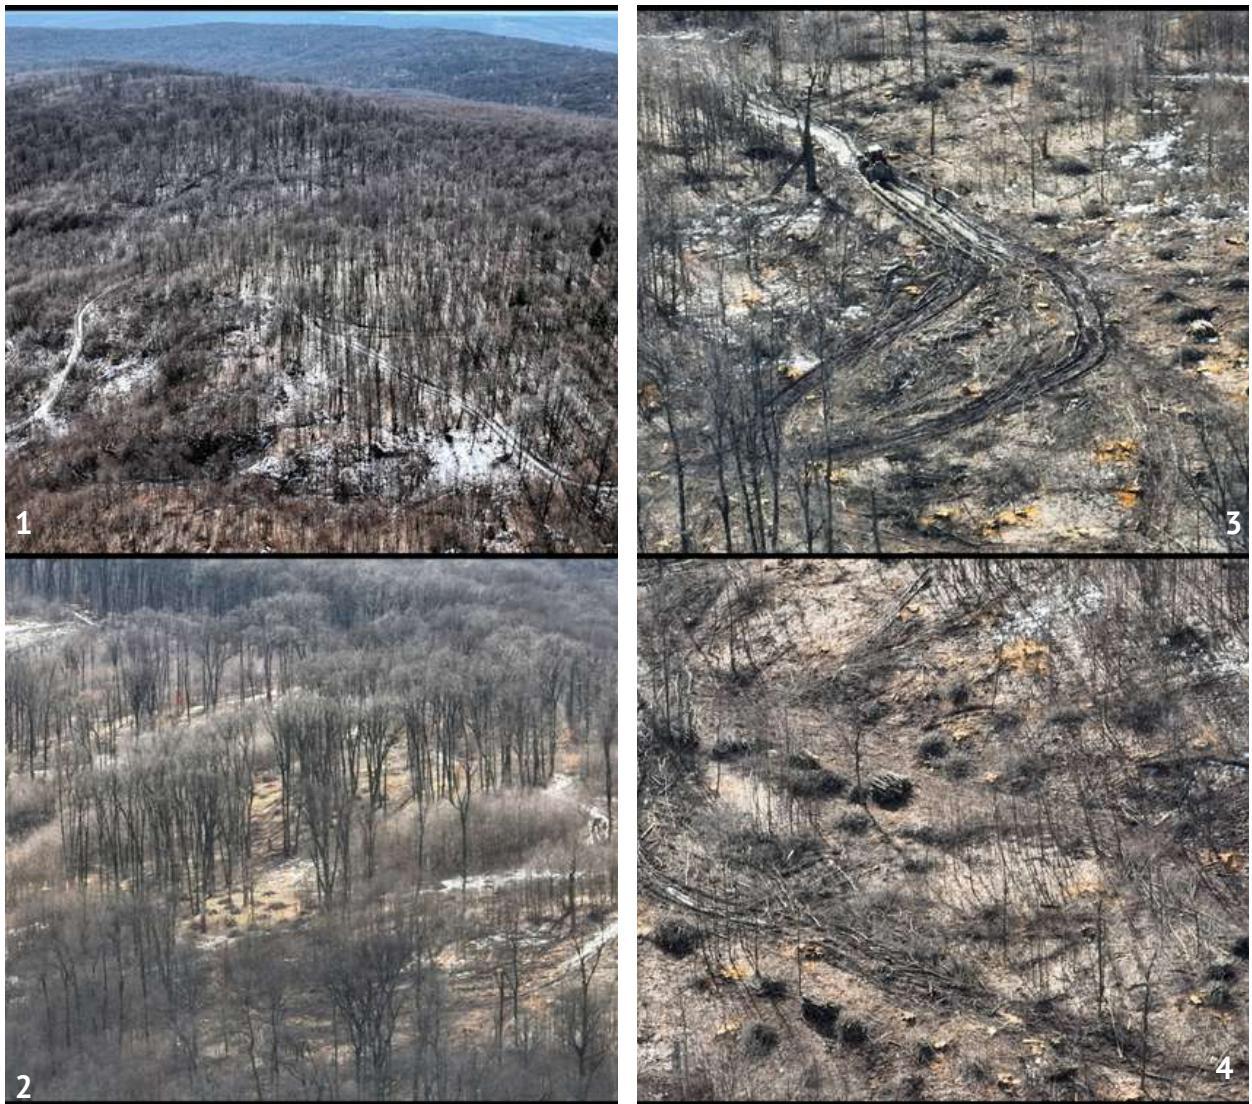
The area is now a heavily fragmented landscape that has been subjected to multiple logging permits. Access to the site on foot was blocked by workers. Therefore, drone footage was used to understand the level of degradation. The area needs to be revisited again to better document the area on foot. Furthermore, analysis of photos reported in Sumal for this area shows trucks leaving logging sites with sawdust. This is controversial as large logs are potentially being chopped in the forest and not declared.

Figure 62: (1) aerial photo of active logging area; (2) aerial close-up of active logging area. (3) Photo of a tractor at work inside logging area; (4) aerial close-up of active logging area. Photos were taken in February 2023.
