This document has been produced by

Ulrich Schwarz

FLUVIUS Floodplain Ecology and River Basin Management

Mediterranean Deltas

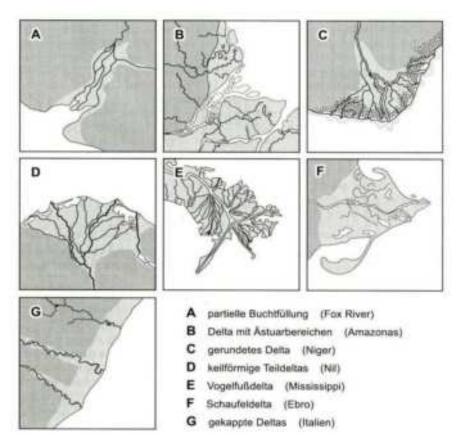
Figure 1: Types of deltas (from Ahnert 2001). The most common Mediterranean delta types are those shown in D, F and G. The Mediterranean deltas are generally river-sediment-driven and not predominantly wave-formed or tidal.

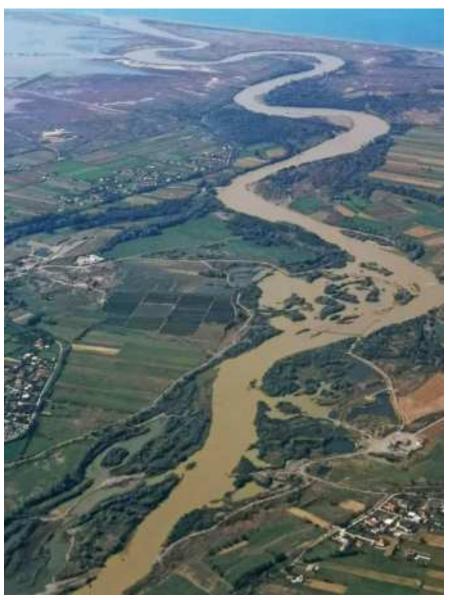
Figure 2: The sediment transport from the mountains to the coastal plains in all grain fractions, particularly coarse material, is essential. The Mati River -due to the blockage of larger grain fractions (i.e. gravel) by several larger dams only transports fine suspended material. This becomes particularly evident by the muddy colour of the river.

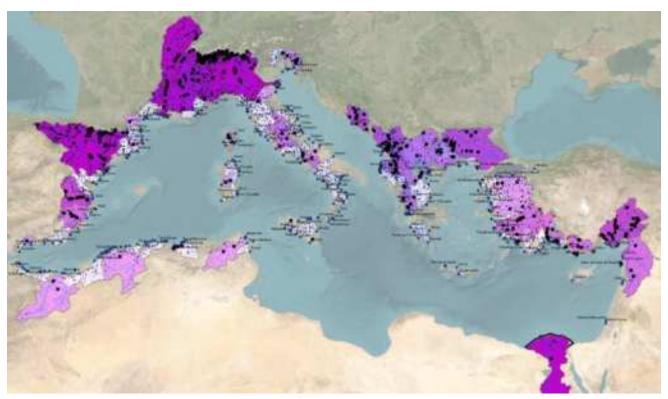
Figure 3: Only a few catchments remain free of large dams (> 10 MW), mostly within less water-rich rivers or rivers with many weirs and small hydropower plants (1-10 MW), e.g.Arno or Piave Rivers in Italy. The second "larger" river remaining without larger hydropower dams is the Pineios River in Greece, which is 217 km long. However, one hydropower dam is under construction in its lower course.

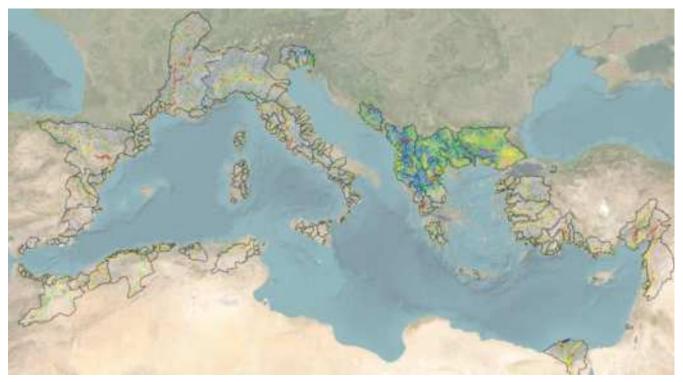
Figure 5: Hydromorphological assessments in five classes are available for rivers located on the Balkan Peninsula (Schwarz 2020a) (high density mapping) and the Mediterranean Region (2017, only major rivers).

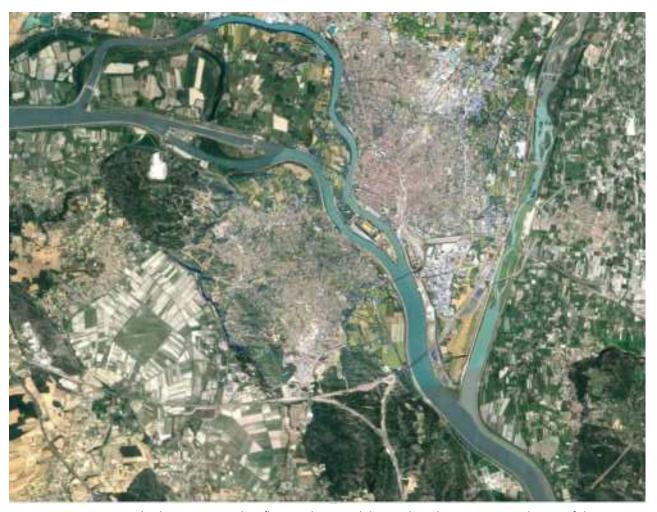
Figure 6: Main rivers and tributaries strongly influence the river deltas and can be seen as an indicator of the intactness of the entire catchments. In the Rhone River (France), strong river regulation, navigation, hydropower development, and sediment retention in barrier reservoirs prevail (Google Earth 2023).

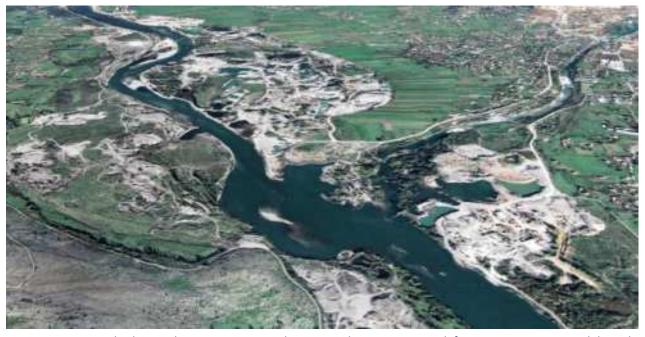
Figure 7: Excessive dredging in lower courses contributes to sediment transport deficits causing incision and degradation of deltas (example from Morača River, Montenegro) (Google Earth 2023).

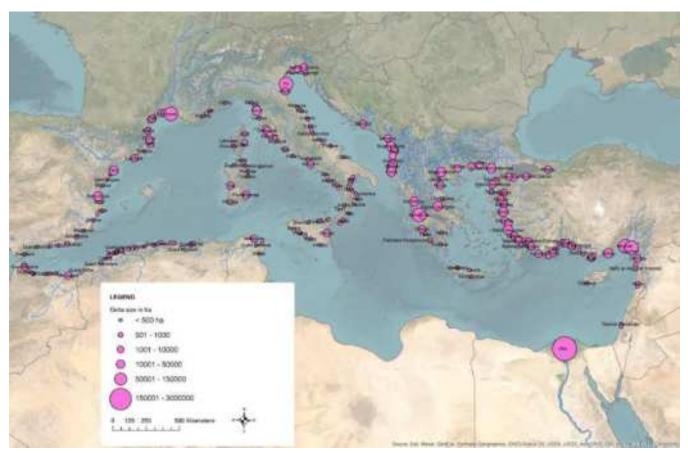
Figure 10: Overview of the 258 mapped deltas and their size classes.

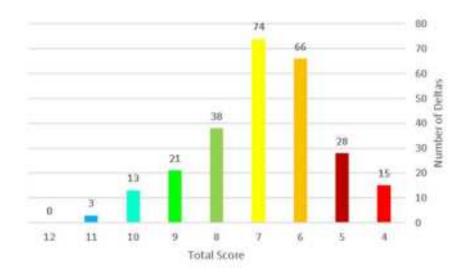
Figure 11: Distribution of assessment scores. Only 6% (16) of all deltas assessed (258) fall into the best scores with total scores of 10 or 11. None of the deltas reached the top score (i.e. 12 points). On average, deltas reached 7 to 9 points (52%), while 42% of the deltas assessed scored only between 4 and 6 points.

Out of 258 assessed deltas, none received the full score of 12, and only three smaller deltas fell in the second-highest scoring, 11. Thirteen deltas are attributed to very good conditions, receiving a score of 10. It's important to highlight that most deltas with scores of 10 and 11 are relatively small.

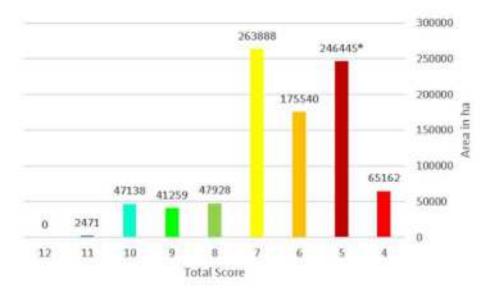
Figure 12: Distribution of the total area size of deltas in ha for each score (*the Nile with 2,768,144 ha scoring 5 points is not included in the chart to prevent distortion). The result drastically shows the poor condition of deltas in the Mediterranean in general. Additionally, no larger delta is still in good shape. Score 10 consists mainly of the few Albanian deltas. All others (including score 11 deltas) are small.

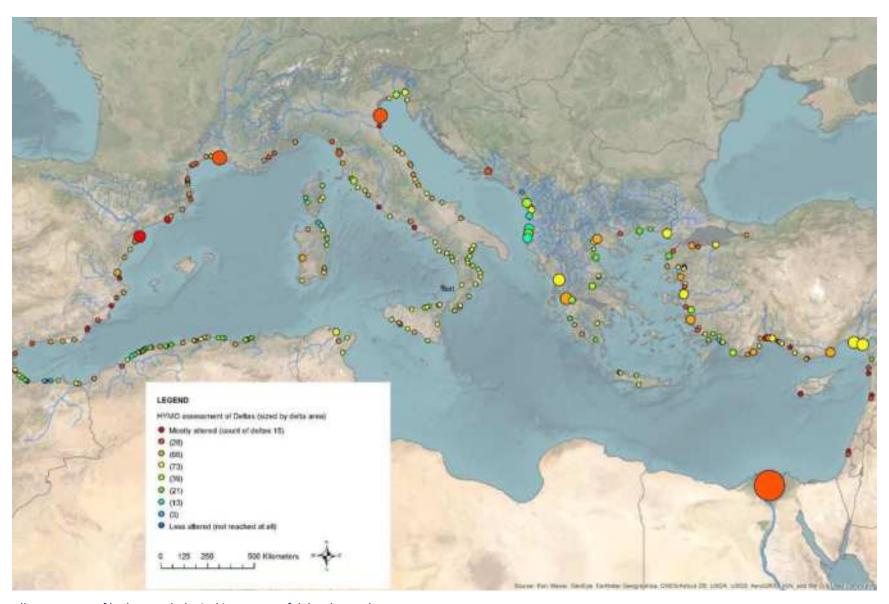
Figure 13: Overall assessment of hydromorphological intactness of deltas by total scores.

Most of the higher-ranked deltas are in the northeastern Mediterranean Basin, while the northwestern (European) part mainly hosts deltas with poor status. All deltas and river mouths in Morocco and Algeria are of small size, which might be a reason for less alteration of those areas. Some small deltas with good conditions still exist in southern Italy and Sicily, as well as in Corsica (France) and Sardinia (Italy). In contrast, the numerous Turkish deltas underwent a continuous decrease in intactness due to hydropower construction, land reclamation and tourism. Greece still hosts a few deltas with rather good conditions. However, the famous Nestos Delta, a protected area (National Park of Eastern Macedonia and Thrace), is significantly impacted by a chain of hydropower reservoirs in its catchment.

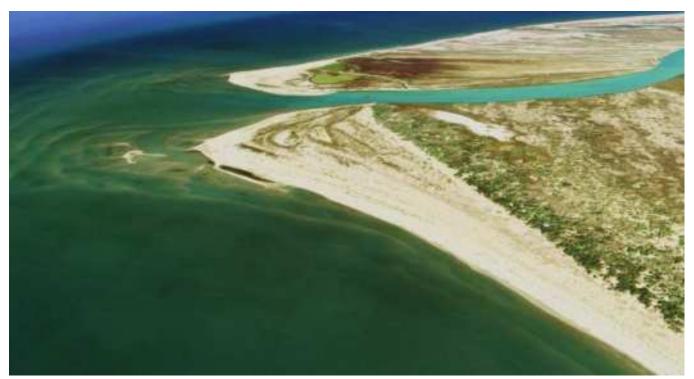
Figure 18: The Vjosa delta mouth provides the most discharge and sediment load of all three deltas. The Vjosa Delta still hosts a remarkable delta front and a highly dynamic small lagoon system, particularly on the southern delta area. On the other hand, agricultural usage has spread into the delta area, and now, fishery activities and impacts of keeping water in the lagoons deteriorate and endanger the site protected as Pishe Poro - Narte Protected Landscape (Google Earth 2023).

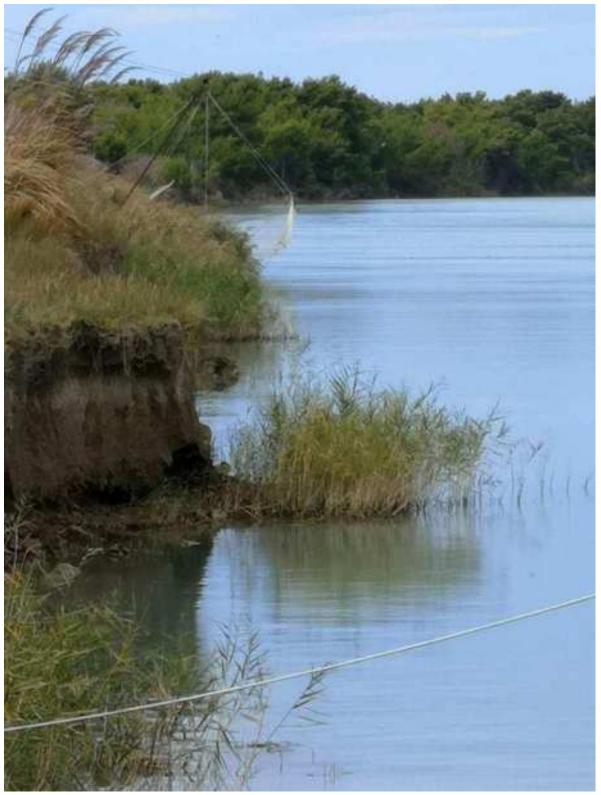
Figure 19: Inside the Vjosa Delta. Shifting channels with side erosion are inevitable for living deltas.

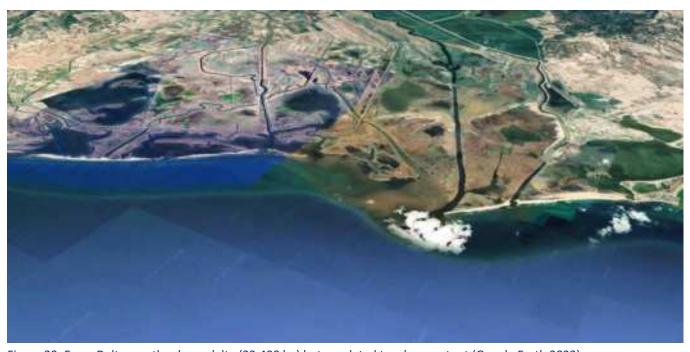
Figure 20: Evros Delta, another large delta (32.400 ha) but regulated to a large extent (Google Earth 2023).

The Evros/Maric Delta on the border between Greece and Turkey (total score 7) still hosts valuable habitats. However, river regulation and excessive irrigation schemes along the lower course of the river significantly reduced the ranking of the hydromorphological intactness. The fresh and brackish water zone is changing within the totally rectified main channel enforcing saltwater intrusion. By strong irrigation upstream the delta and its canal systems, the natural shield of freshwater keeping seawater away from land is deteriorated and pollution can be concentrated in those regulated confluences.

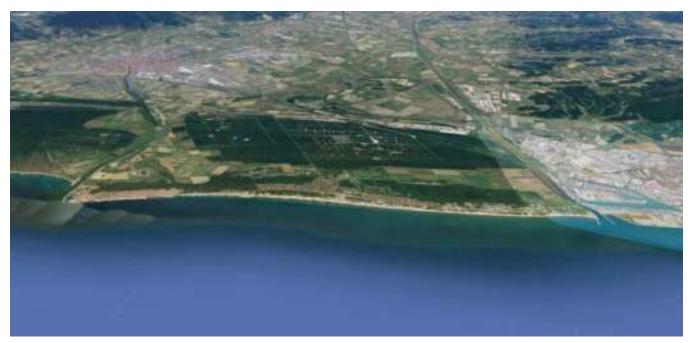
Figure 21: Extensively altered delta of the Arno River in Italy (Google Earth 2023).

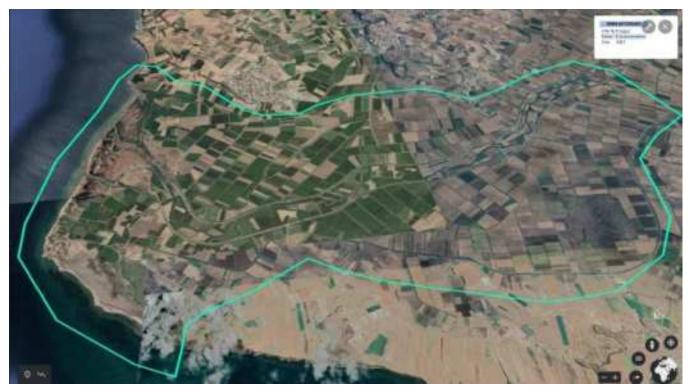
The construction of flood dykes disconnects large delta areas from natural processes of flooding and sediment aggradation, and parallel canals built for irrigation and drainage harm the hydrological regime and increase pollution load in the split channels (Google Earth 2023).

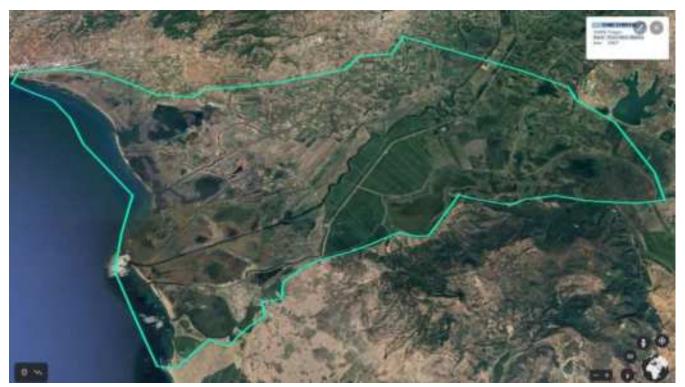
River regulation affects many deltas, leading to completely changed flood distribution and deltaic development. Changing, even dredging, lower river courses can cause saltwater intrusion and severe problems for agriculture and water supply (Google Earth 2023).

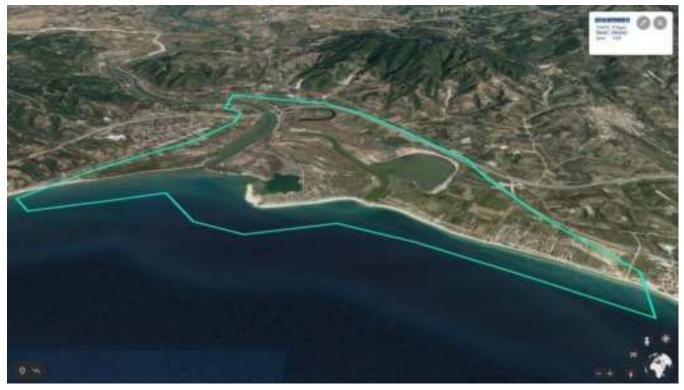
Engineered deltas comprise channel regulation and constructions such as dam and sluice systems to former lagoons, harbours and settlements (Google Earth 2023).

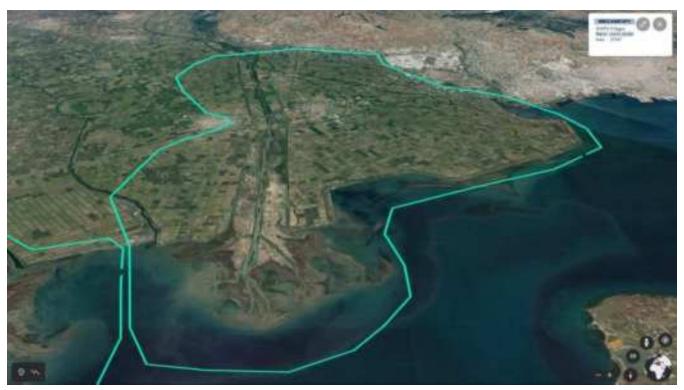
Due to human interaction, the delta type varies, or its behaviour is intensified. In this case, the strongly regulated lower channel increases slope and stream power, generating a crowfoot delta with various small front channels (Google Earth 2023).

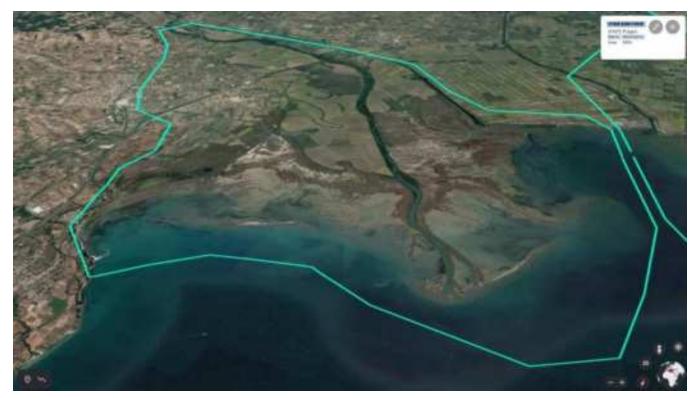
As in previous examples, this double delta covers a vast area. However, the numerous constructions of large hydropower dams in the river's middle course cause a drop of transported sediments, which results in a decreasing delta area as material to "produce" such is missing (Google Earth 2023).

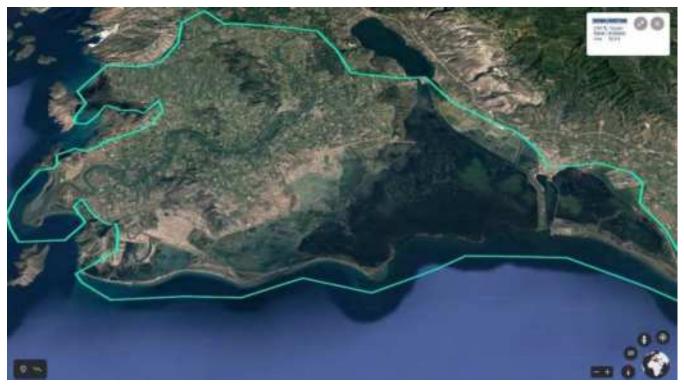
River regulation prevents the natural and regular shift of main delta channels, causing long-term coastline erosion and a decrease in deltas. To protect the coast, construction of dykes and coastal protection measures are needed (Google Earth 2023).

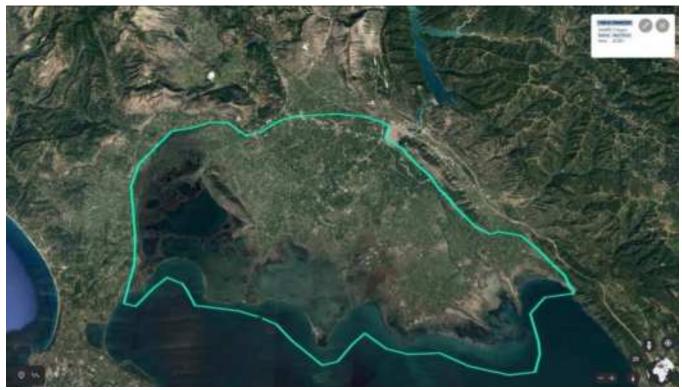
If sediments are caught behind major dams, the fertile delta lowlands become prone to be eroded by waves. Additionally, saltwater intrusion can limit growth conditions and freshwater supply for households (Google Earth 2023).

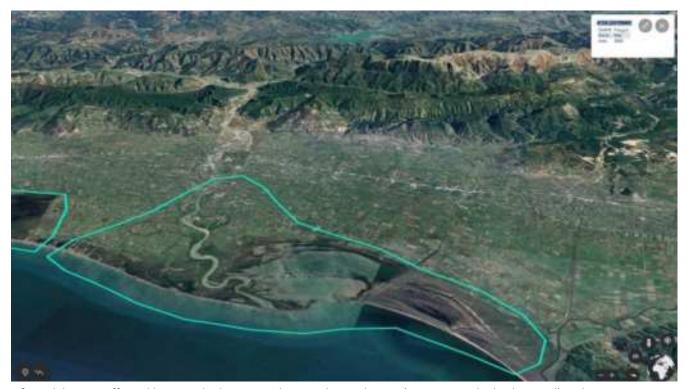
Often, deltas are affected by many hydropower plants in the catchment (reservoir in the background) and intensive sediment dredging along the lower courses (where the river enters the plain). But this image also shows the coast's vulnerability and the vital function of deltas for coastal protection. (Google Earth 2023).

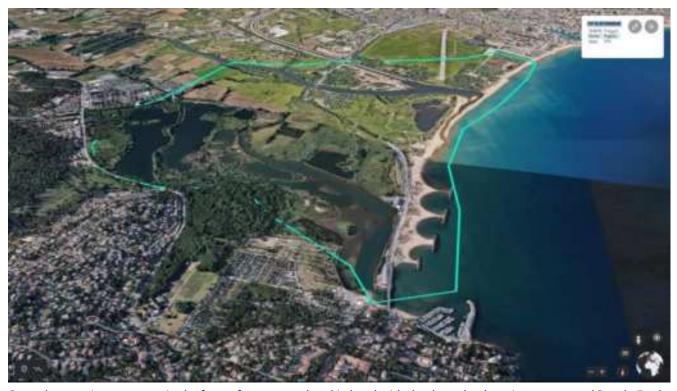
Coastal protection measures in the form of groynes go hand in hand with the dense land use in many areas (Google Earth 2023).
