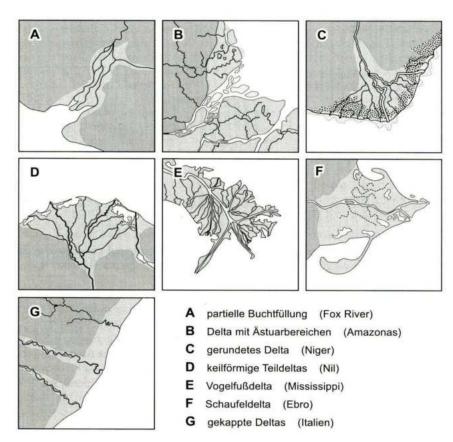
Figure 1: Types of deltas (from Ahnert 2001). The most common Mediterranean delta types are those shown in D, F and G. The Mediterranean deltas are generally river-sediment-driven and not predominantly wave-formed or tidal.

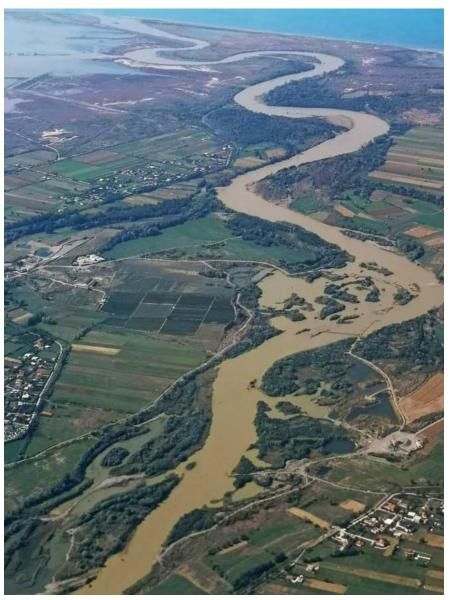
Figure 2: The sediment transport from the mountains to the coastal plains in all grain fractions, particularly coarse material, is essential. The Mati River -due to the blockage of larger grain fractions (i.e. gravel) by several larger dams only transports fine suspended material. This becomes particularly evident by the muddy colour of the river.

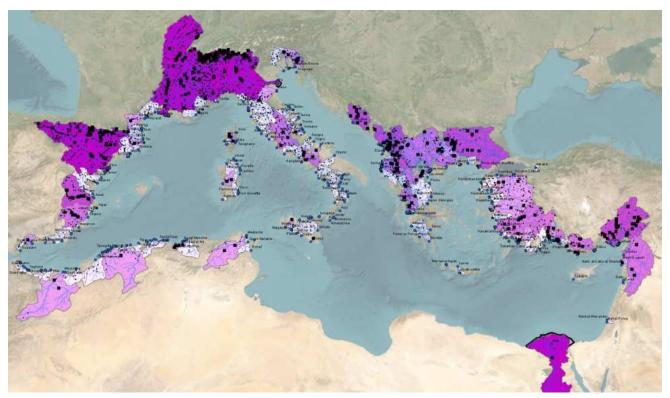
Figure 3: Only a few catchments remain free of large dams (> 10 MW), mostly within less water-rich rivers or rivers with many weirs and small hydropower plants (1-10 MW), e.g.Arno or Piave Rivers in Italy. The second "larger" river remaining without larger hydropower dams is the Pineios River in Greece, which is 217 km long. However, one hydropower dam is under construction in its lower course.

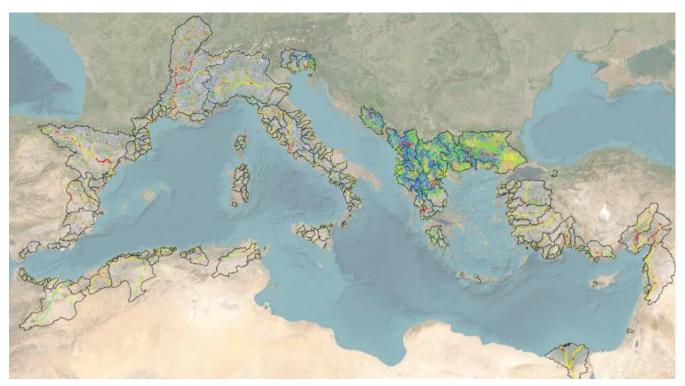
Figure 5: Hydromorphological assessments in five classes are available for rivers located on the Balkan Peninsula (Schwarz 2020a) (high density mapping) and the Mediterranean Region (2017, only major rivers).

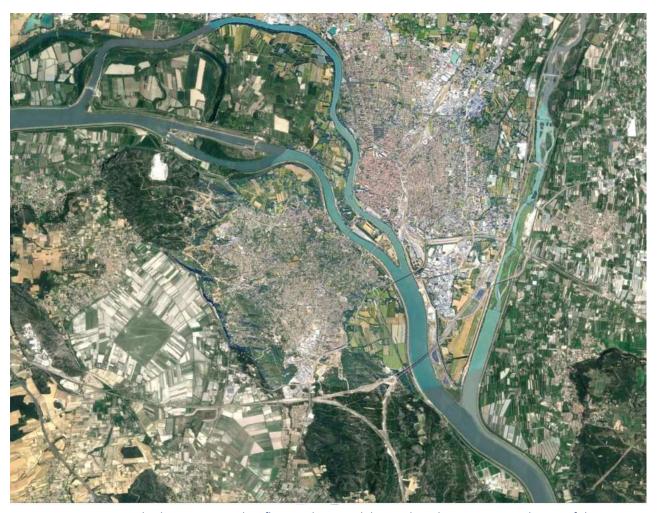
Figure 6: Main rivers and tributaries strongly influence the river deltas and can be seen as an indicator of the intactness of the entire catchments. In the Rhone River (France), strong river regulation, navigation, hydropower development, and sediment retention in barrier reservoirs prevail (Google Earth 2023).

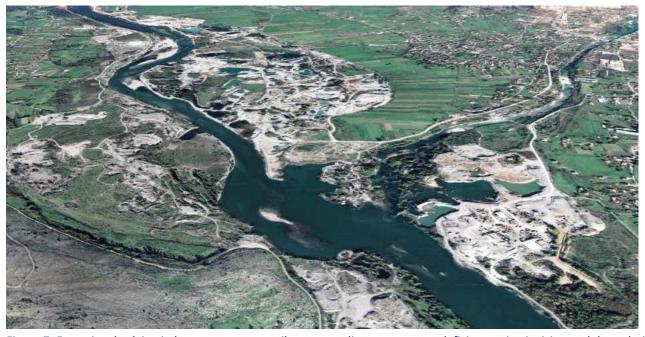
Figure 7: Excessive dredging in lower courses contributes to sediment transport deficits causing incision and degradation of deltas (example from Morača River, Montenegro) (Google Earth 2023).

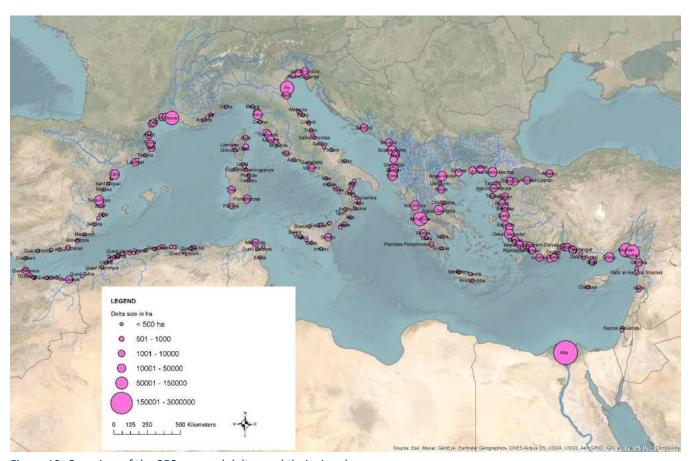
Figure 10: Overview of the 258 mapped deltas and their size classes.

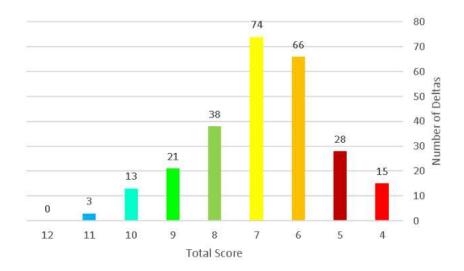
Figure 11: Distribution of assessment scores. Only 6% (16) of all deltas assessed (258) fall into the best scores with total scores of 10 or 11. None of the deltas reached the top score (i.e. 12 points). On average, deltas reached 7 to 9 points (52%), while 42% of the deltas assessed scored only between 4 and 6 points.

Out of 258 assessed deltas, none received the full score of 12, and only three smaller deltas fell in the second-highest scoring, 11. Thirteen deltas are attributed to very good conditions, receiving a score of 10. It's important to highlight that most deltas with scores of 10 and 11 are relatively small.

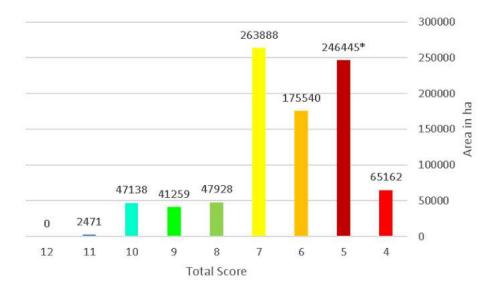
Figure 12: Distribution of the total area size of deltas in ha for each score (\*the Nile with 2,768,144 ha scoring 5 points is not included in the chart to prevent distortion). The result drastically shows the poor condition of deltas in the Mediterranean in general. Additionally, no larger delta is still in good shape. Score 10 consists mainly of the few Albanian deltas. All others (including score 11 deltas) are small.

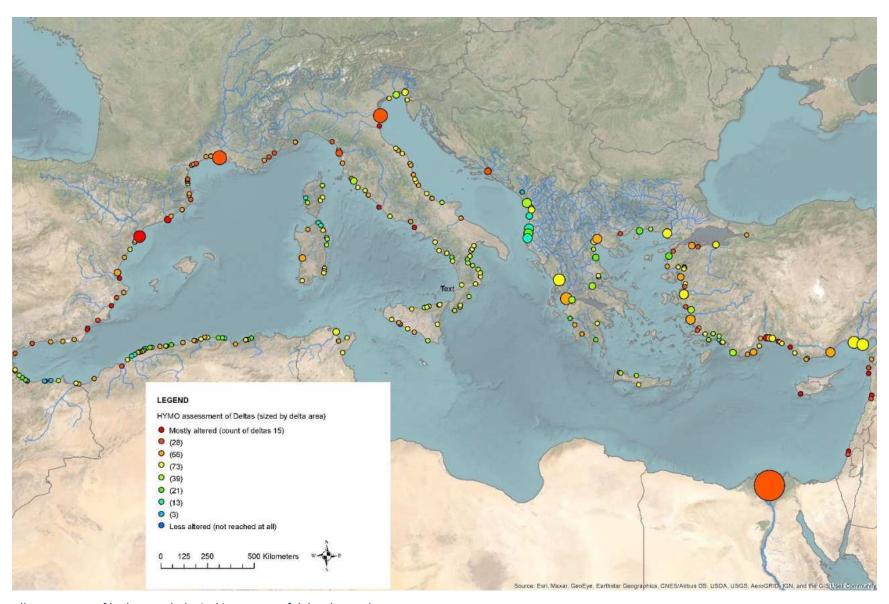
Figure 13: Overall assessment of hydromorphological intactness of deltas by total scores.

Most of the higher-ranked deltas are in the northeastern Mediterranean Basin, while the northwestern (European) part mainly hosts deltas with poor status. All deltas and river mouths in Morocco and Algeria are of small size, which might be a reason for less alteration of those areas. Some small deltas with good conditions still exist in southern Italy and Sicily, as well as in Corsica (France) and Sardinia (Italy). In contrast, the numerous Turkish deltas underwent a continuous decrease in intactness due to hydropower construction, land reclamation and tourism. Greece still hosts a few deltas with rather good conditions. However, the famous Nestos Delta, a protected area (National Park of Eastern Macedonia and Thrace), is significantly impacted by a chain of hydropower reservoirs in its catchment.

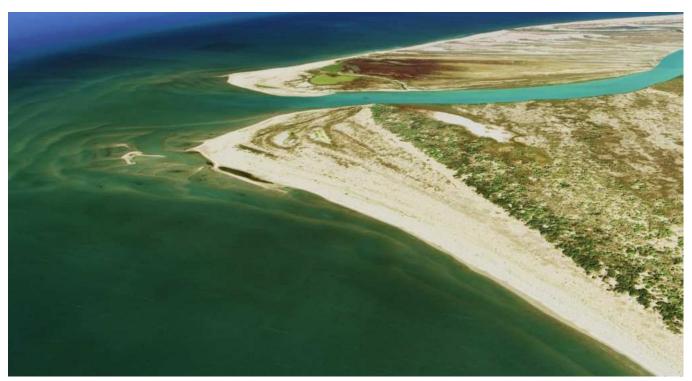
Figure 18: The Vjosa delta mouth provides the most discharge and sediment load of all three deltas. The Vjosa Delta still hosts a remarkable delta front and a highly dynamic small lagoon system, particularly on the southern delta area. On the other hand, agricultural usage has spread into the delta area, and now, fishery activities and impacts of keeping water in the lagoons deteriorate and endanger the site protected as Pishe Poro - Narte Protected Landscape (Google Earth 2023).

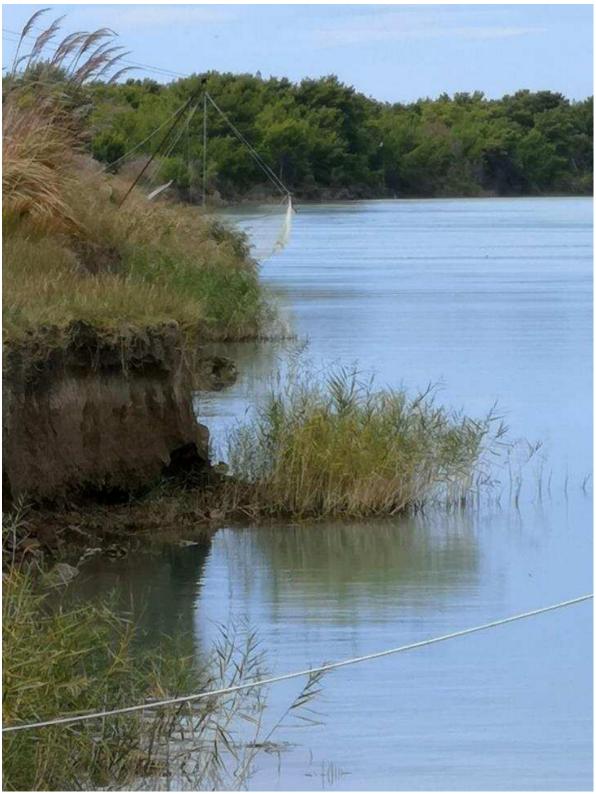
Figure 19: Inside the Vjosa Delta. Shifting channels with side erosion are inevitable for living deltas.

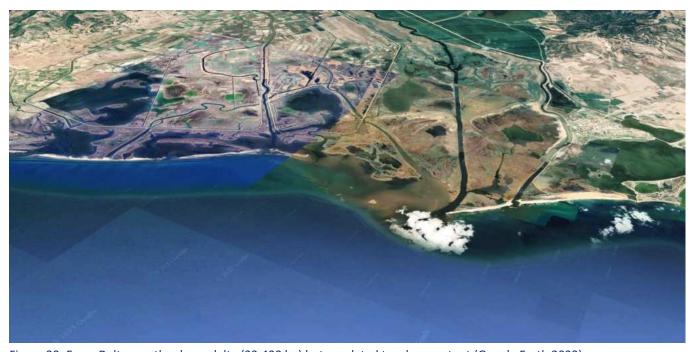
Figure 20: Evros Delta, another large delta (32.400 ha) but regulated to a large extent (Google Earth 2023).

The Evros/Maric Delta on the border between Greece and Turkey (total score 7) still hosts valuable habitats. However, river regulation and excessive irrigation schemes along the lower course of the river significantly reduced the ranking of the hydromorphological intactness. The fresh and brackish water zone is changing within the totally rectified main channel enforcing saltwater intrusion. By strong irrigation upstream the delta and its canal systems, the natural shield of freshwater keeping seawater away from land is deteriorated and pollution can be concentrated in those regulated confluences.

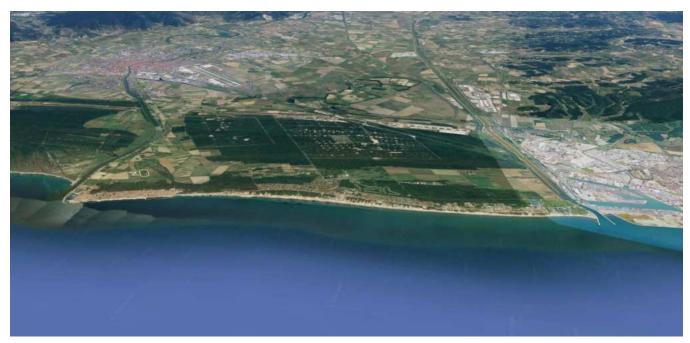
Figure 21: Extensively altered delta of the Arno River in Italy (Google Earth 2023).

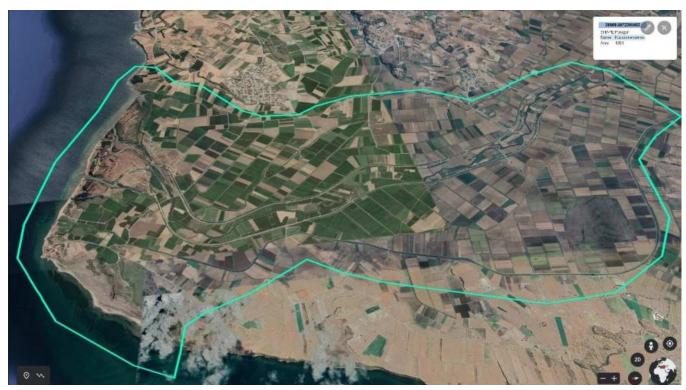
The construction of flood dykes disconnects large delta areas from natural processes of flooding and sediment aggradation, and parallel canals built for irrigation and drainage harm the hydrological regime and increase pollution load in the split channels (Google Earth 2023).

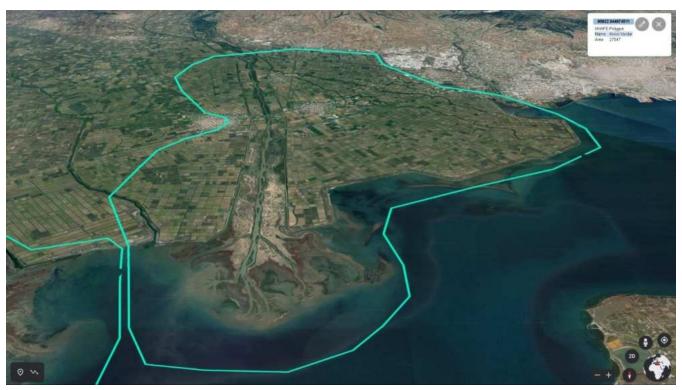
Due to human interaction, the delta type varies, or its behaviour is intensified. In this case, the strongly regulated lower channel increases slope and stream power, generating a crowfoot delta with various small front channels (Google Earth 2023).

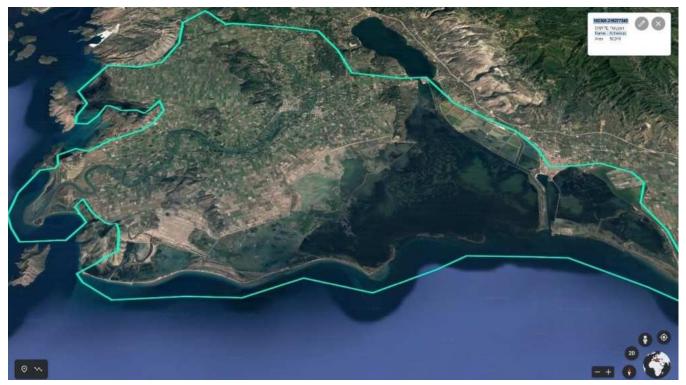
River regulation prevents the natural and regular shift of main delta channels, causing long-term coastline erosion and a decrease in deltas. To protect the coast, construction of dykes and coastal protection measures are needed (Google Earth 2023).

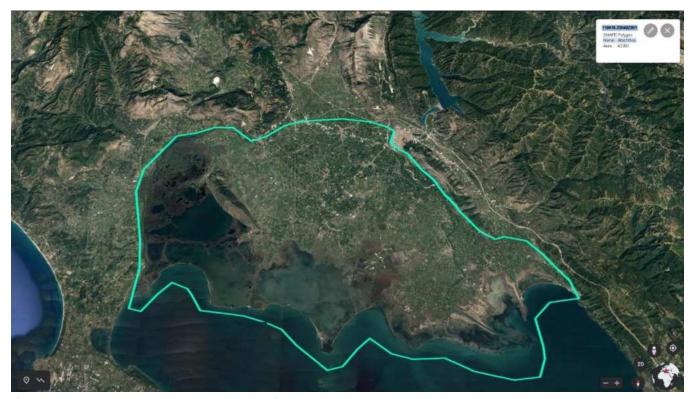
If sediments are caught behind major dams, the fertile delta lowlands become prone to be eroded by waves. Additionally, saltwater intrusion can limit growth conditions and freshwater supply for households (Google Earth 2023).

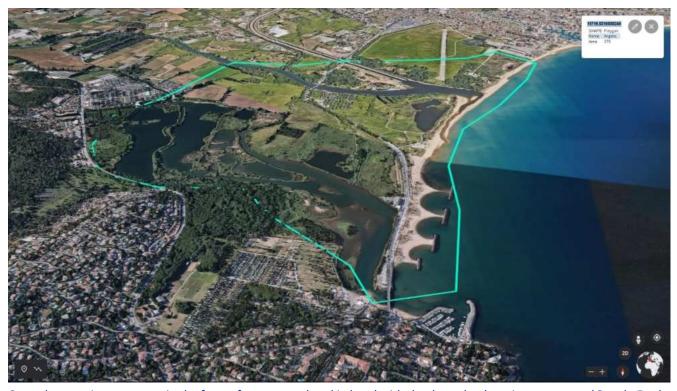
Coastal protection measures in the form of groynes go hand in hand with the dense land use in many areas (Google Earth 2023).
